**ULF FRANSSON**

# Pre-Roman Iron age houses at Vik: An analysis of construction, function and social significance

### ABSTRACT

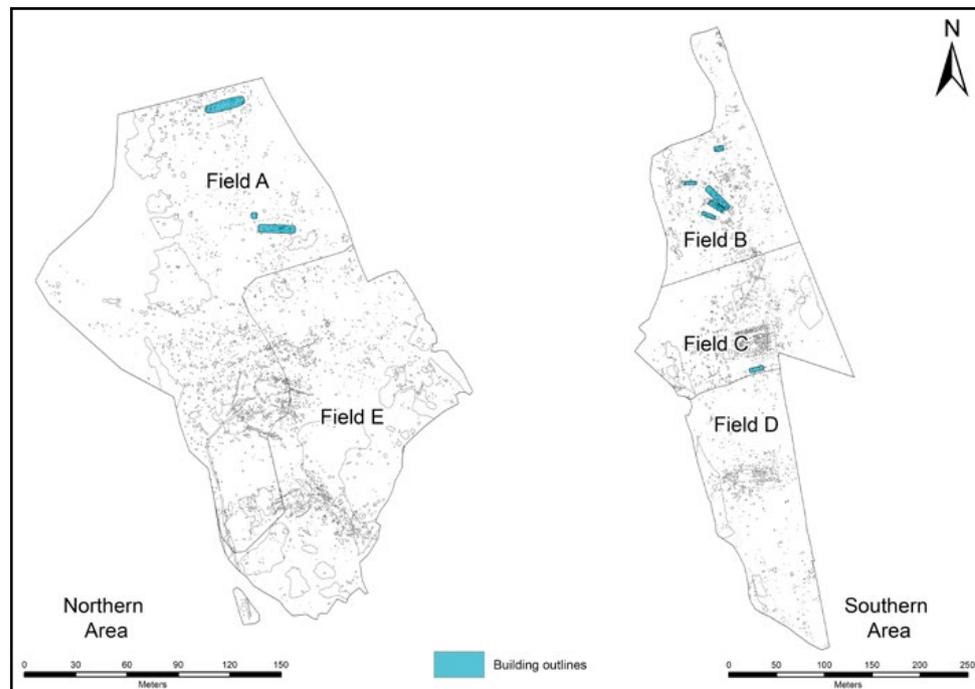
**Figure 2.** Overview of the excavation area with pre-Roman Iron Age archaeological features: Longhouses, cooking pits, and wells. Map: Magnar Mojaren Gran, NTNU University Museum.

The excavations at Vik revealed 10 longhouses, two outbuildings, several cooking pits and two wells

dated to the pre-Roman Iron Age (Figures 1 and 2). All the postholes of the buildings have been excavated, and artefacts and palebotanic material have been analysed. The longhouses varied considerably in construction, design and size.

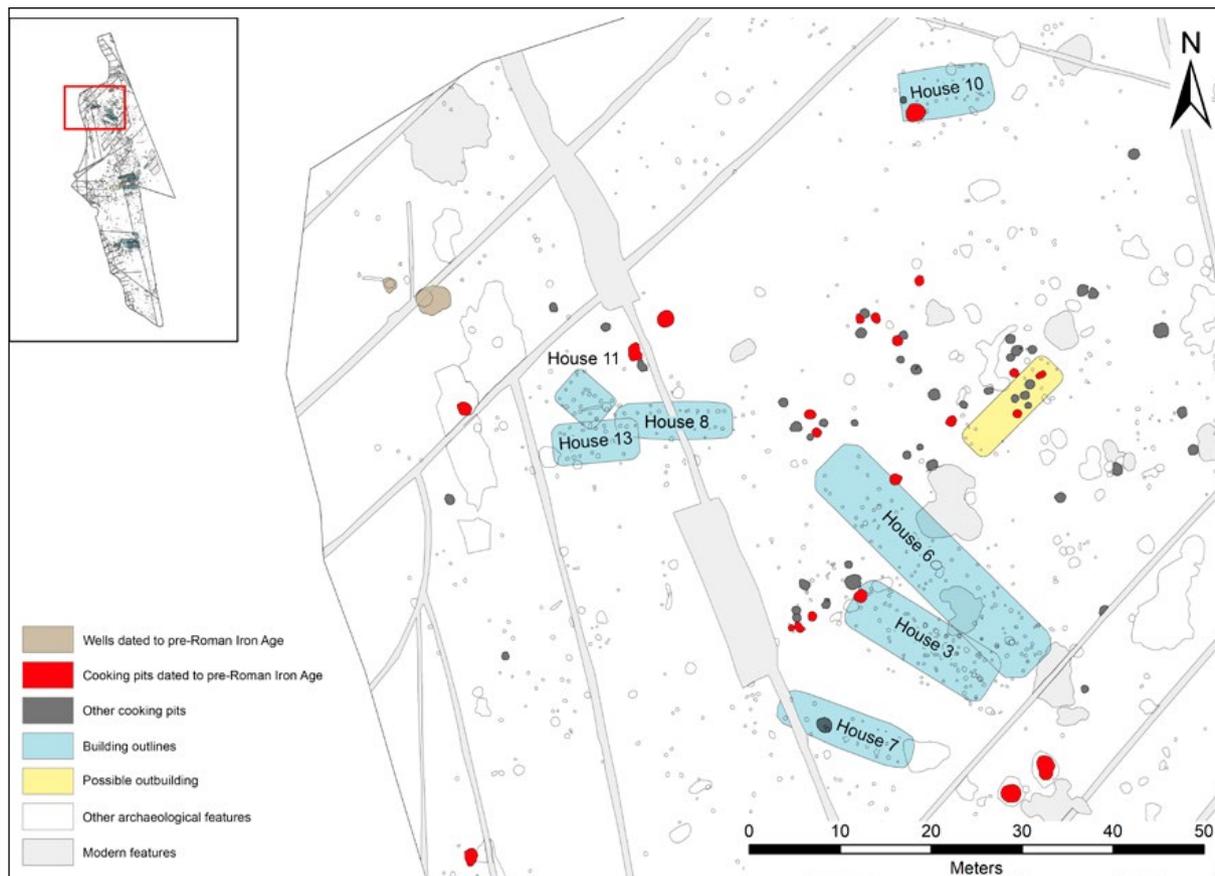
**Figure 3.** Archaeological features and buildings from the pre-Roman Iron Age in Field B. Map: Illustration: Magnar Mojaren Gran, NTNU University Museum.

Houses 3 and 7 probably burned down and were abandoned during PRIA 2. They are the earliest longhouses with a new, and at Vik unusual, north-western – south-eastern orientation (Figure 3).

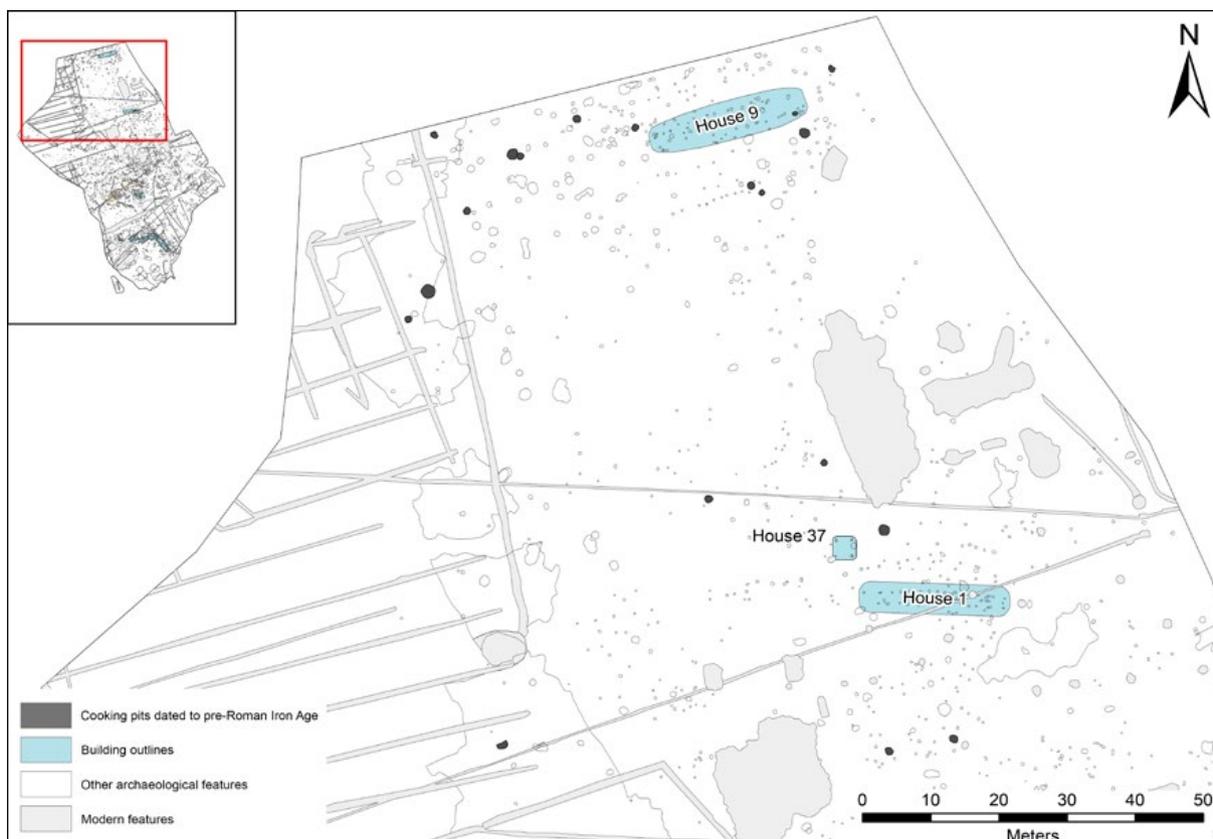
**Figure 4.** Archaeological features and buildings from the pre-Roman Iron Age in Field A. Map: Illustration: Magnar Mojaren Gran, NTNU University Museum.

longhouses and one outbuilding were excavated (Figure 4). Most parts of Field A were used during the pre-Roman Iron Age. This is evident not least from the fact that cooking pits from the period are scattered throughout the area.

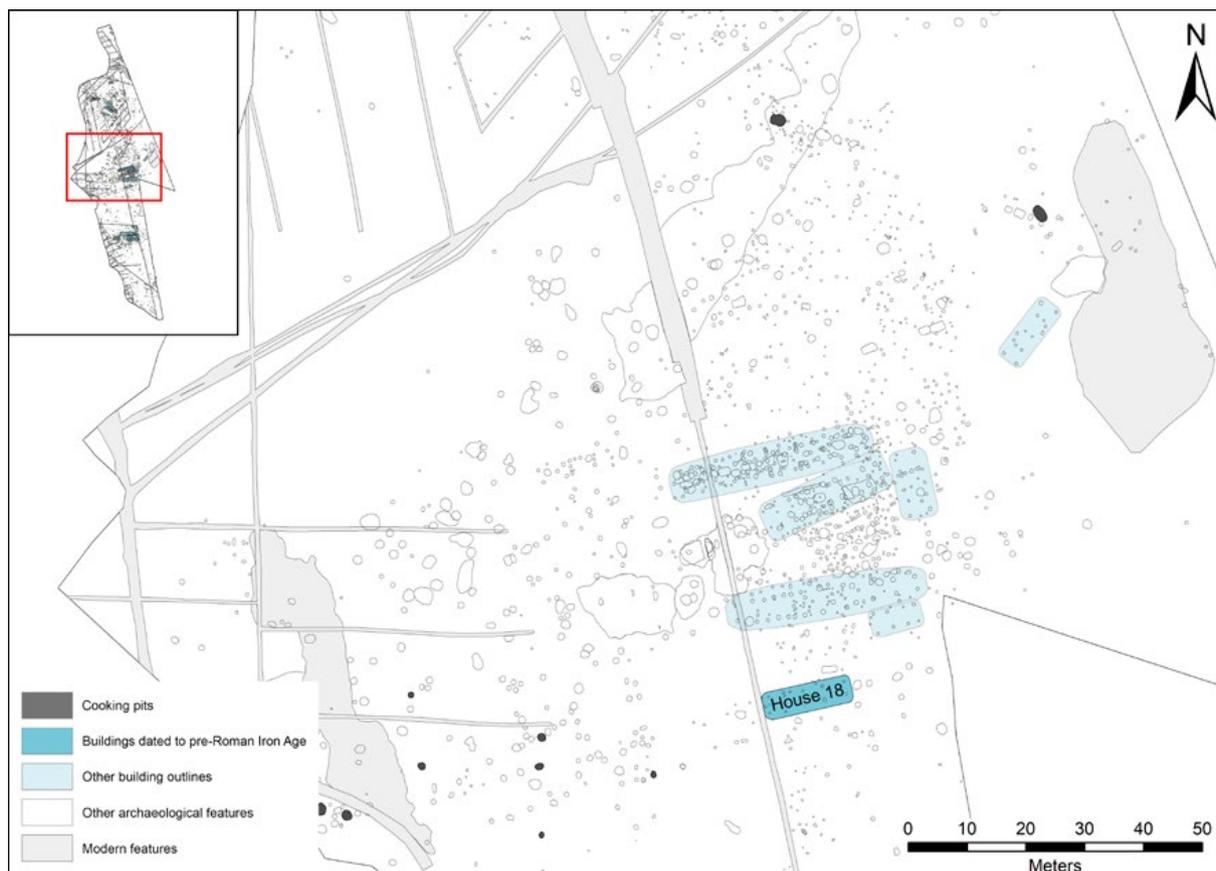
**Figure 5.** Archaeological features and buildings from the pre-Roman Iron Age in Field C. Map: Illustration: Magnar Mojaren Gran, NTNU University Museum.

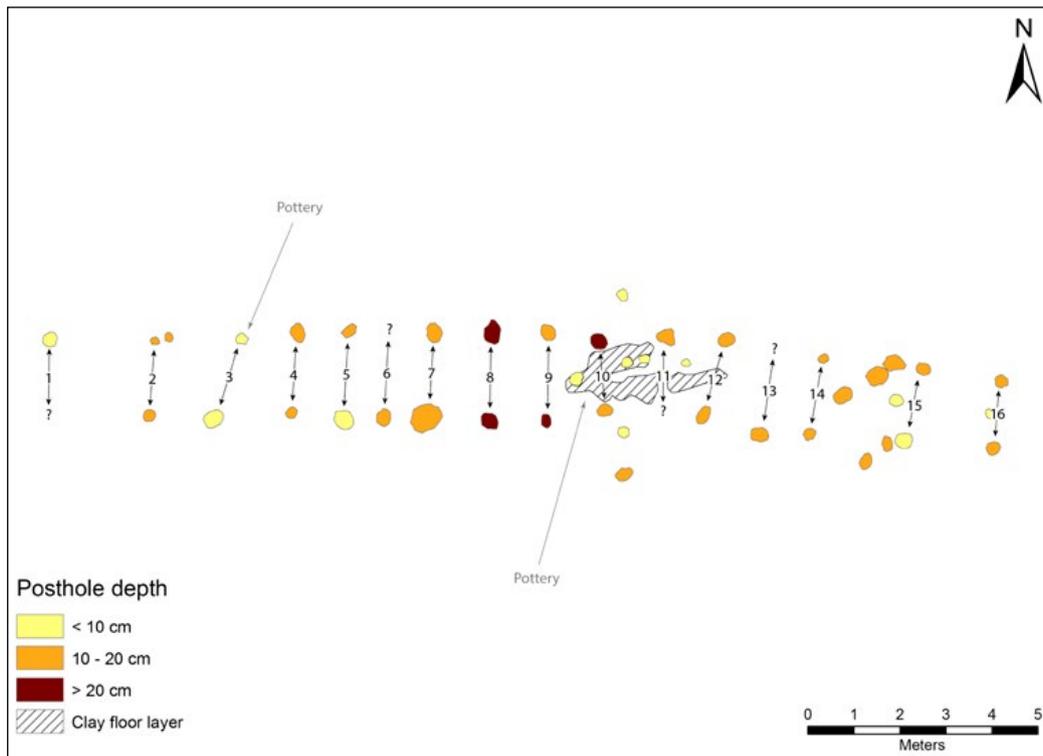
**Figure 6.** House 1, Field A. Illustration: Magnar Mojaren Gran, NTNU University Museum.

The best-preserved longhouse was House 1 (Figure 6), but the eastern part was skewed relative to the rest of the longhouse. Two reasons for this can be suggested. First, that there may have been another small building on site; second, that this part of the longhouse could have been damaged by a modern ditch. Two shards of ceramics tempered with igneous rock were found in the western part of the longhouse. There was also a fragment of a crucible. The interpretation is that the site has probably been used for forging, or that a forge had been located on the site. This assumption is strengthened by analyses of hard-burned clay from the eastern part of the building (Mokkelbost 2018b:139–142).

Despite the later disturbance, House 1 was characterized by the fact that the distance between the trestles was shorter in the central part and longer towards the gables; this was clearest towards the west end. There was also a complementary third row of roof-supporting posts along the central axis of the longhouse (Figure 6). The longhouse may have

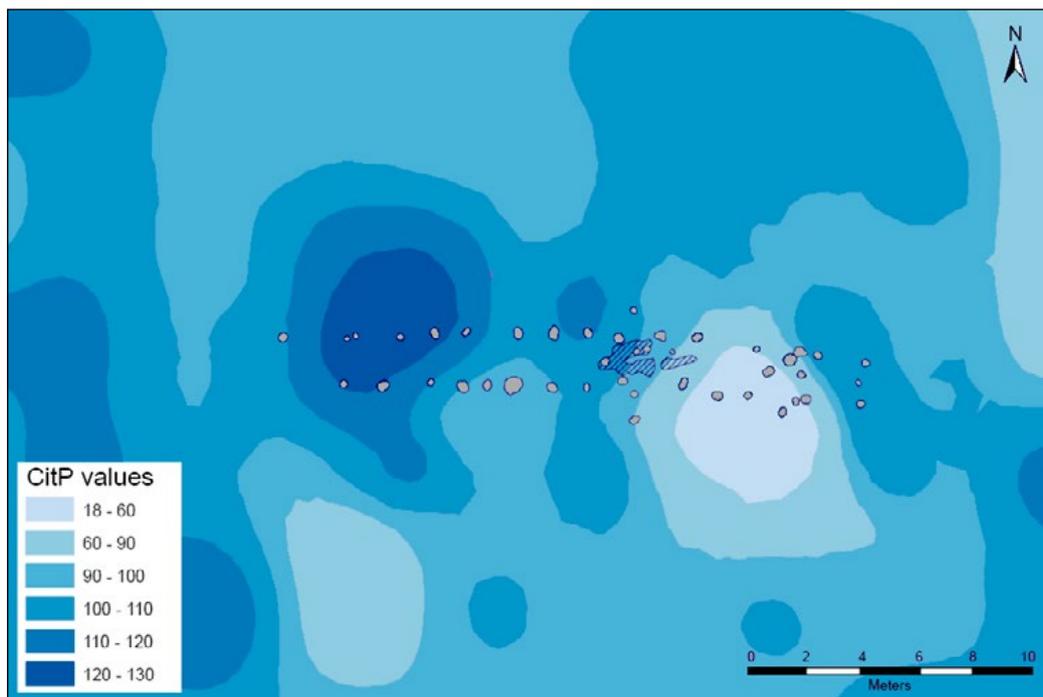
**Figure 7.** Spatial distribution of soil phosphate content (Cit-P) in and around House 1. Illustration: Magnar Mojaren Gran, NTNU University Museum.

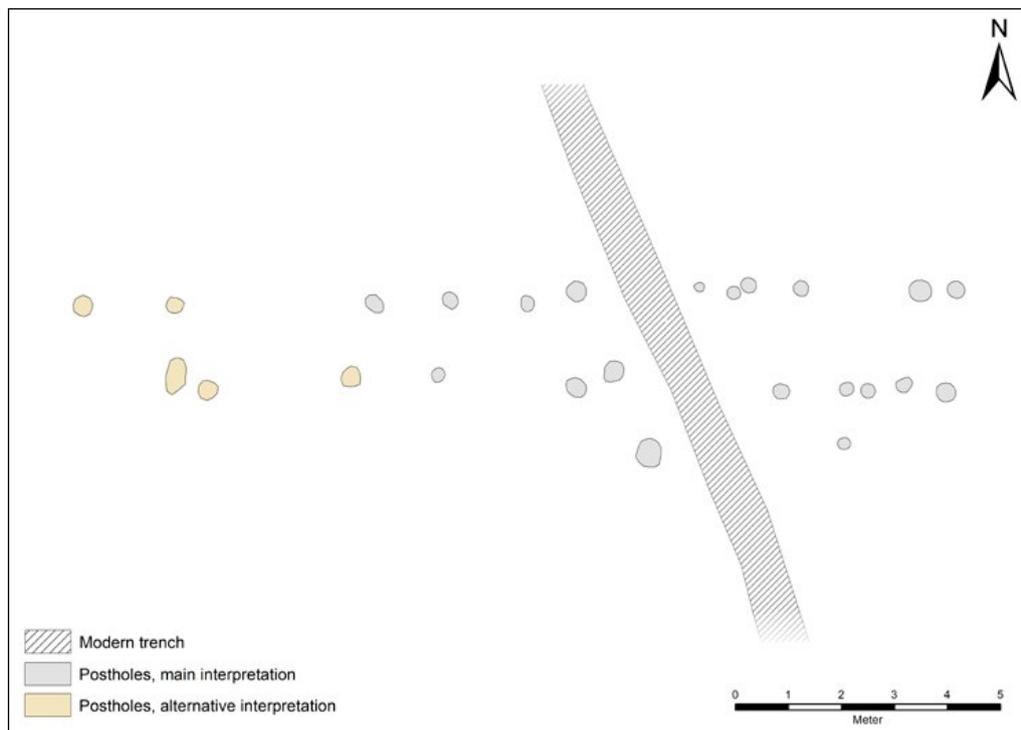
**Figure 8.** House 8, Field B. The plan presents two alternative interpretations of the western part of the house. Illustration: Magnar Mojaren Gran, NTNU University Museum.

House 8 in Field B was disturbed in the middle and west parts, and probably only the eastern part of House 10 remained (Figures 8 and 9). Despite extensive disturbance, the three oldest longhouses had markedly similar central aisles in terms of their

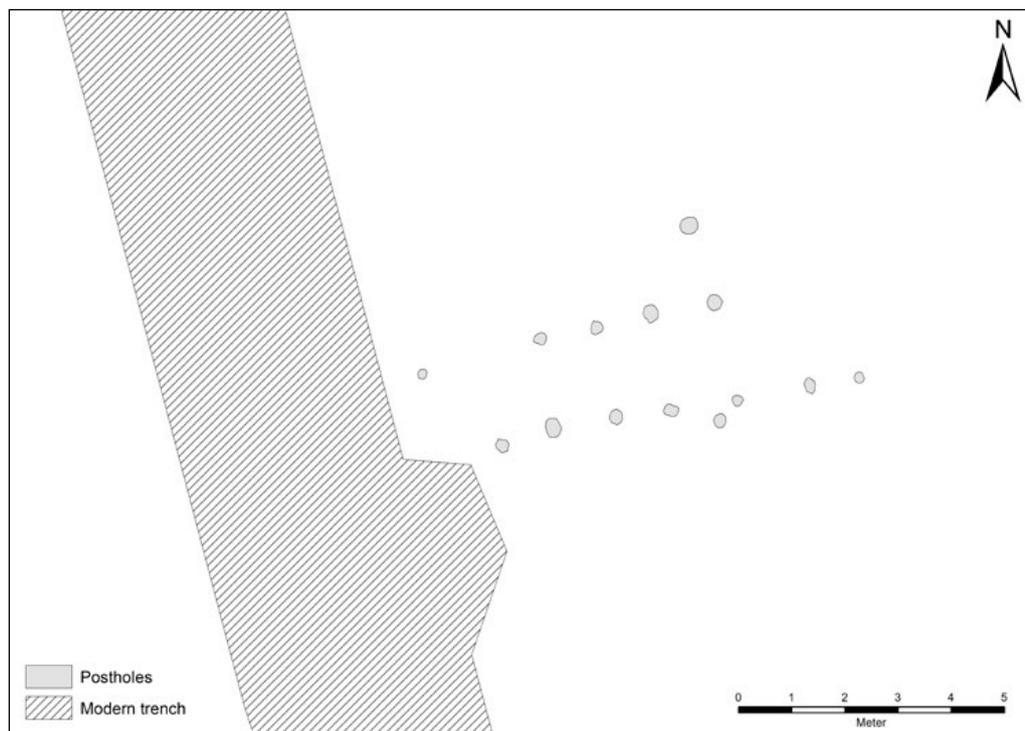
**Figure 9.** House 10, Field B. Illustration: Magnar Mojaren Gran, NTNU University Museum.

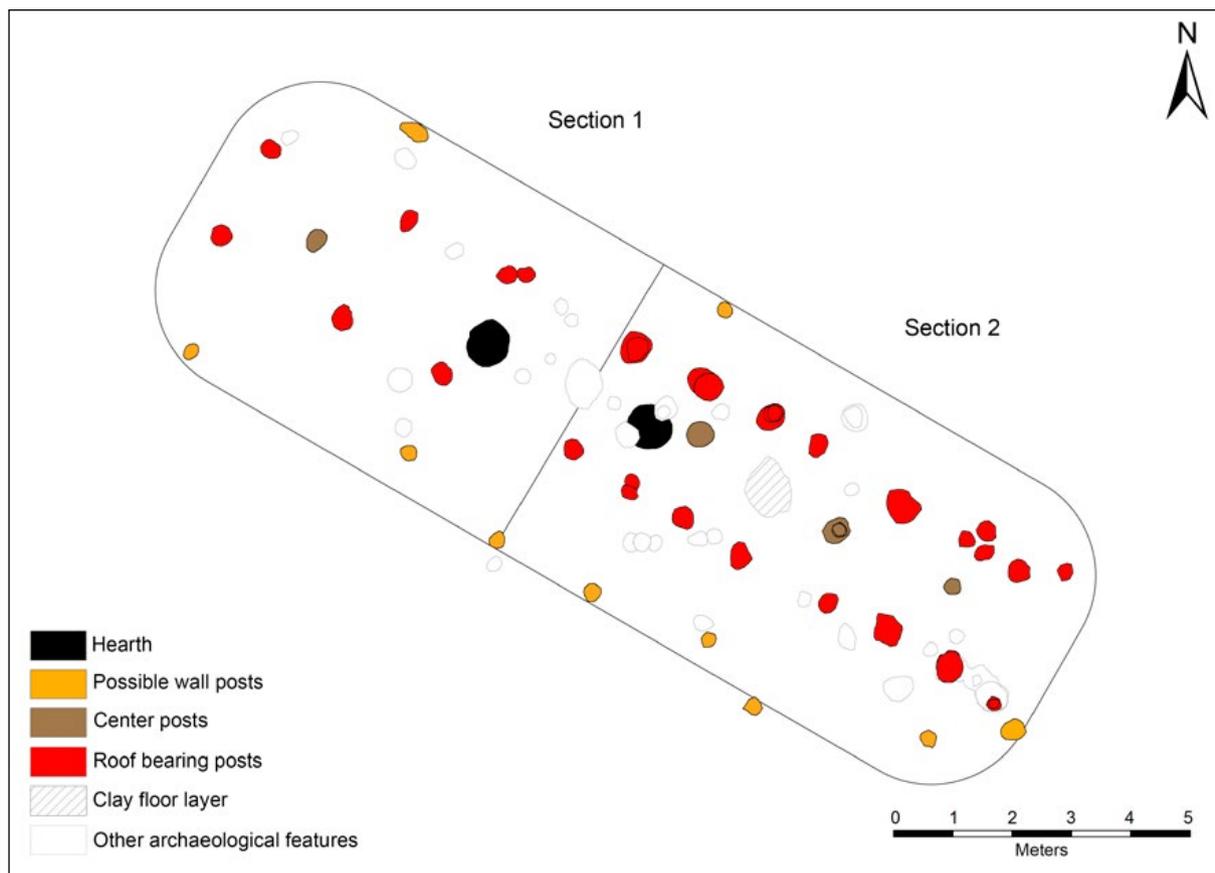
Figure 10. House 3, Field B. Illustration: Magnar Mojaren Gran, NTNU University Museum.

The best-preserved House 3 was divided into two sections (Figure 10). The dwelling part was in the northwest end of the house, where there were long distances between the trestles. In the southeast part, the postholes were much closer together, and there were many additional postholes. There were

The postholes being so close together in the southeastern part of House 3 can indicate a barn. In the possible barn area there were remains of a clay floor (Figure 10). However, it has been pointed out that it would not have been practical to have a clay floor in a barn, at least not in the absence of a

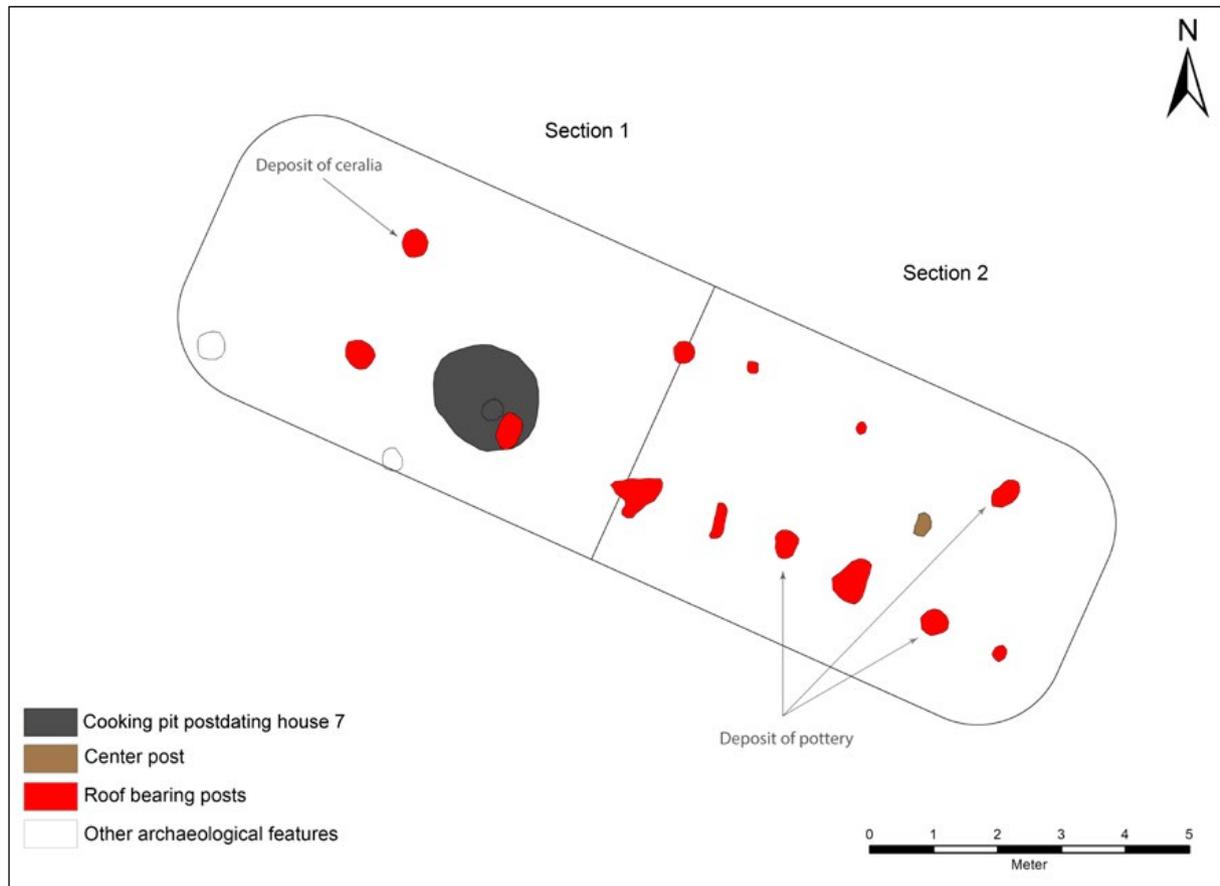
Figure 11. House 7, Field B. Illustration: Magnar Mojaren Gran, NTNU University Museum.

House 7 was also divided into two sections (Figure 11). The row of postholes in the northeast part of House 7 was less well preserved than the row in the

However, at Vik, the conditions were complex because ceramics were also found in Houses 1 and 7 (Figure 11). As in House 6, most of the shards in House 7 were found in the south-west part of the longhouse. It is also possible to interpret these finds as waste (Fransson 2018: 428–429). However, in Field B shards of ceramics were found only in the longhouses, although a large number of other structures from the pre-Roman Iron Age were excavated. This indicates that pottery has been treated differently in different contexts on the area. Together with the similarity between the houses and the location of the deposits in post-holes suggests that the deposits were intentional. Ritual deposits of pottery in postholes is a well-known phenomenon, but better documented in southern Scandinavia (Carlie 2004: 47–57, 65, 202–205, Figure 11.4).

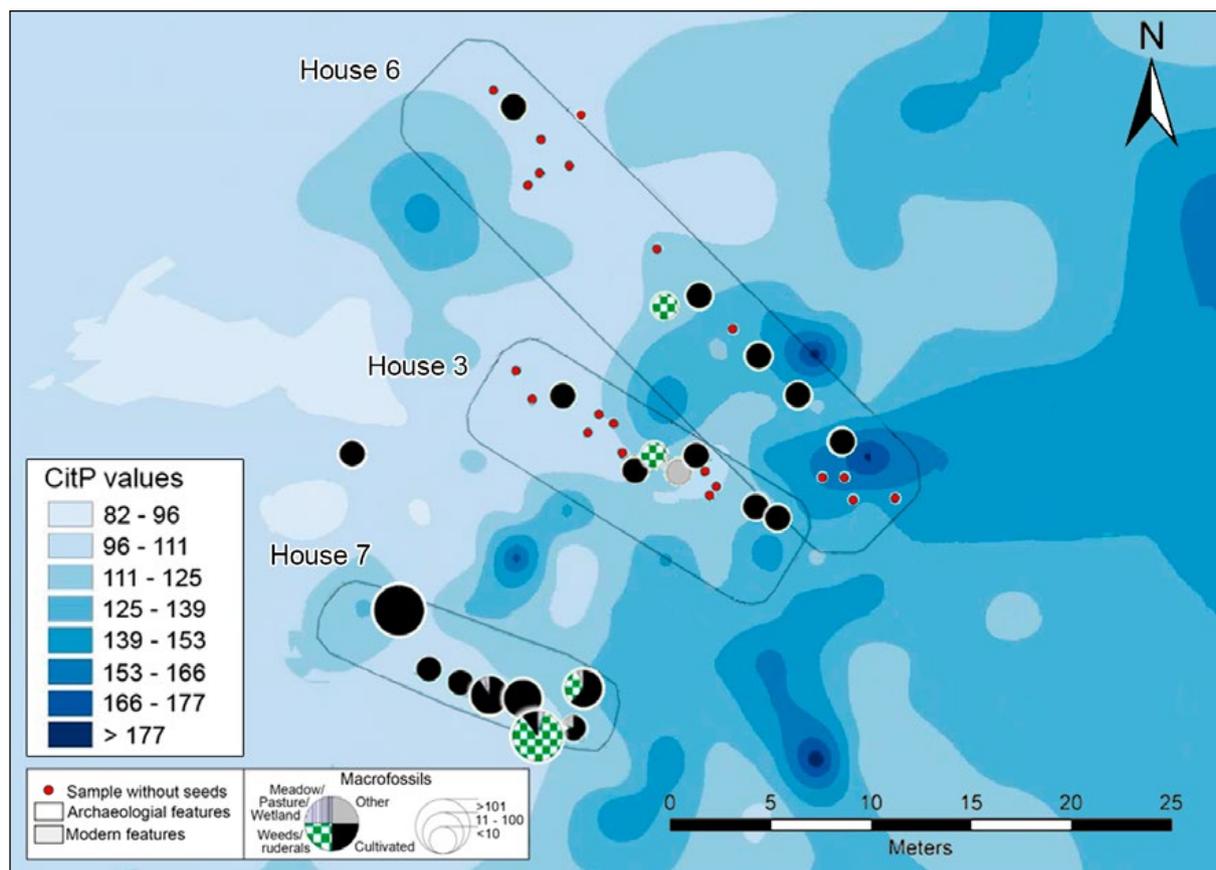
**Figure 12.** Houses 3, 6 and 7, Field B. Relative number and proportion of plant macrofossil remains and spatial distribution of soil phosphate content (Cit-P). Illustration: Magnar Mojaren Gran, NTNU University Museum.

houses indicate that domestic animals were kept outside the south end of the two longhouses (Figure 12). The impression is supported by the results of paleobotanical analysis. Although there were finds of carbonised grains of barley in House 3, there were no traces of meadow and/or wetland seeds in the material. This is despite the fact that there were significant amounts of straw in the samples, which suggests that the preservation conditions were sufficient for such fragile remains to survive. Meadow and/or wetland seeds should have survived to a similar degree if they had been present (Buckland 2017: 43, Figure 39, 42–43).

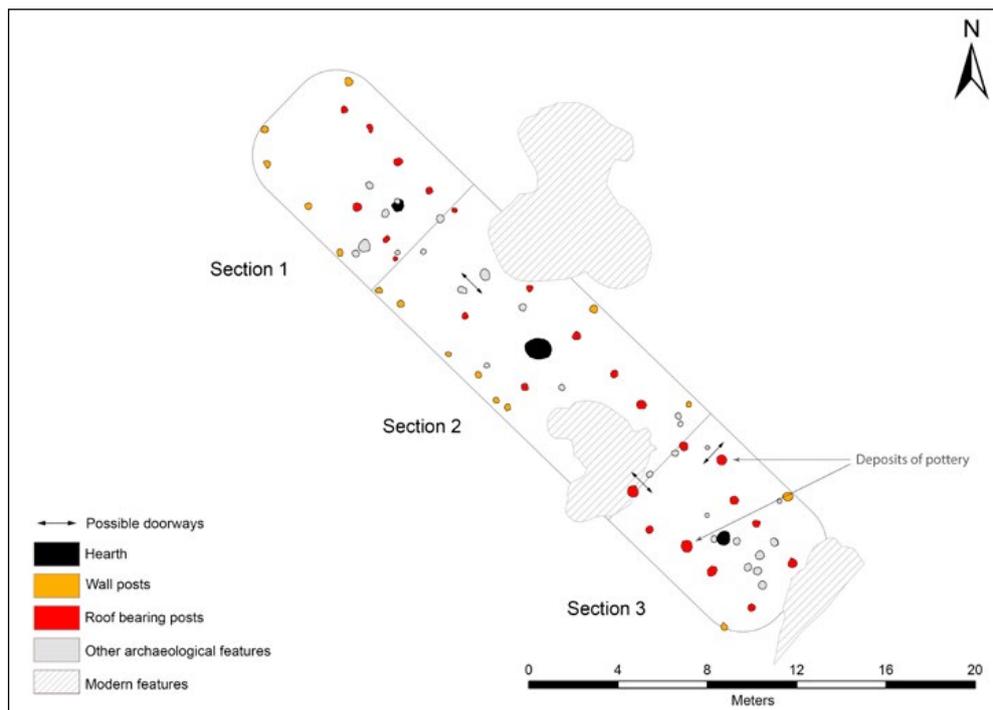
**Figure 13.**  
House 6, Field B.  
Illustration:  
Magnar Mojaren  
Gran, NTNU  
University  
Museum.

in the middle that probably constituted the dwelling section, and two smaller sections in each end. Additionally, there was an oval hearth in the centre of the dwelling area. Two adjacent postholes were found a few metres northeast of the hearth in the dwelling area. They probably indicate the position of an internal door. This in turn may indicate that the longhouse had more internal divisions than is apparent from the position of the trestles (Figure 13).

A comparable deposit of pottery was found in the southern part of House 6 at Vik (Figure 13). Most of the shards were found in the southwestern posthole in the southern rectangle, with comparatively deep postholes (see above). Another large shard of pottery was found in one of the postholes associated with the eastern external door in the same part of the longhouse (Fransson 2018: 397, Figure 8.25). All the ceramic shards were found near the dug hearth in the southeast, and can be interpreted as waste. The fact that the former finding was made in the bottom part of the posthole, and that the shards were so crushed, suggests that they were deposited before the roof-supporting post was placed in the posthole (Fransson 2018: 397, Fig 8.25).

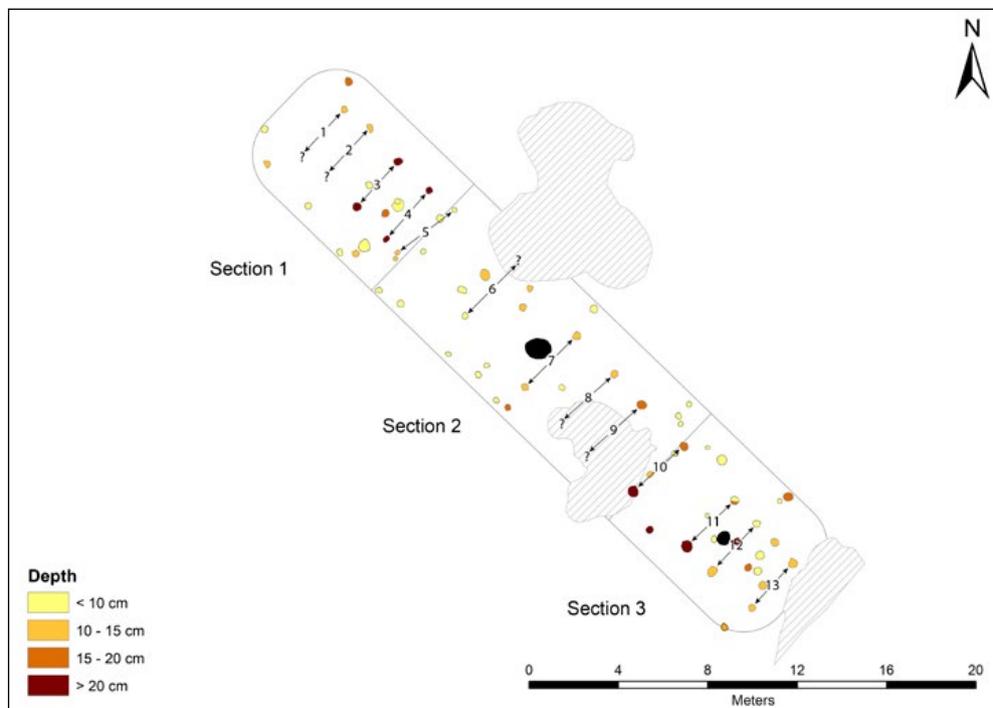
**Figure 14.** House 6, Field B, trestle pairs and posthole depth indicated. Illustration: Magnar Mojaren Gran, NTNU University Museum.

In the vicinity of the gables of House 6, there were two adjacent trestles that formed two rectangles. The four postholes within these rectangles were comparatively deep (Figure 14). On both sides of the southeastern rectangular structure, there were postholes that probably represented two opposing external doors. One 'door' is uncertain, but the structures can nevertheless be interpreted as an entrance room, with the dwelling area to the north-west and a working area in the south-east (Fransson 2018:390-396). A deposit of ceramics was found in the bottom part of the southwestern posthole in the southern rectangle. The 26 small pieces were tempered with igneous rock and had a glossy surface. In the northeastern part of the same rectangle, a larger shard was found. It had the same temper and color as the other, smaller shards. It was deposited in a posthole that may have been a part of an outer doorway (Fransson 2018: 397, Fig 8.25).

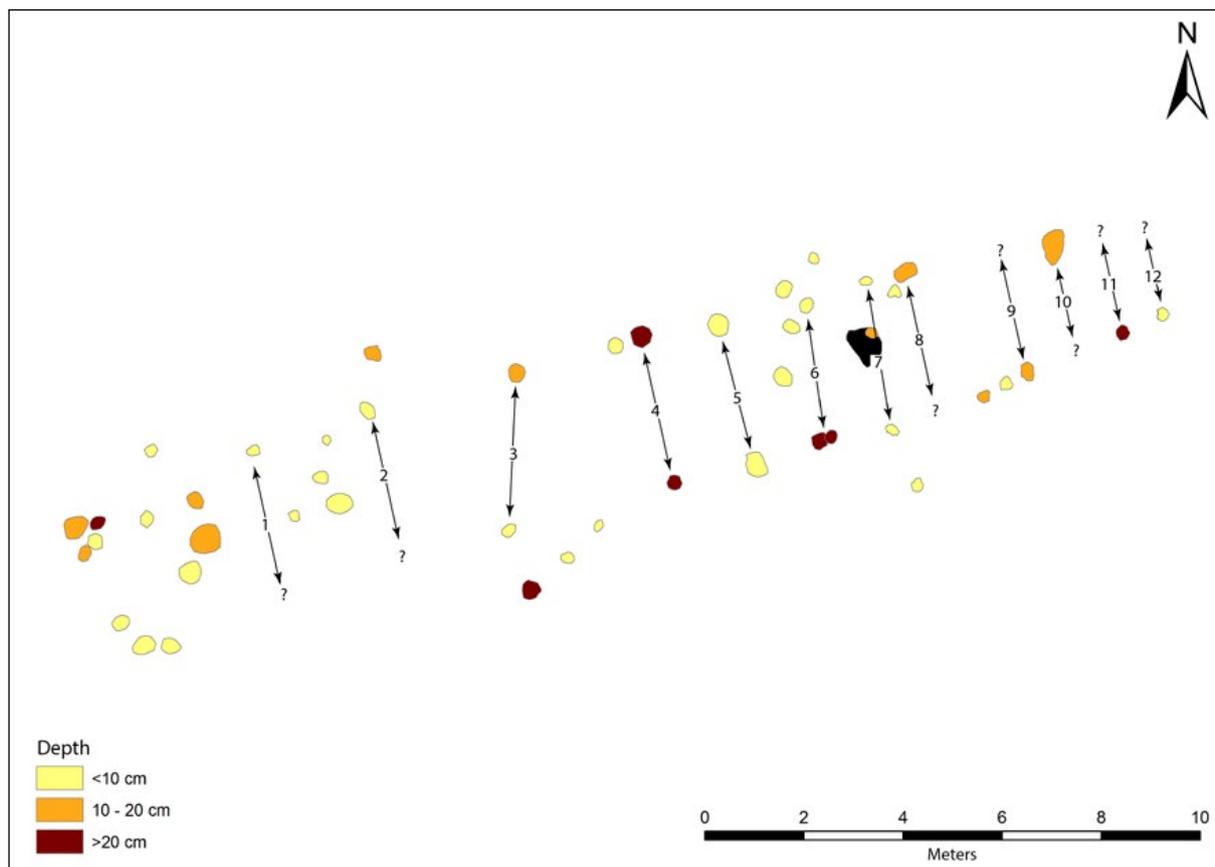
Figure 15. House 9, Field A. Illustration: Magnar Mojaren Gran, NTNU University Museum.

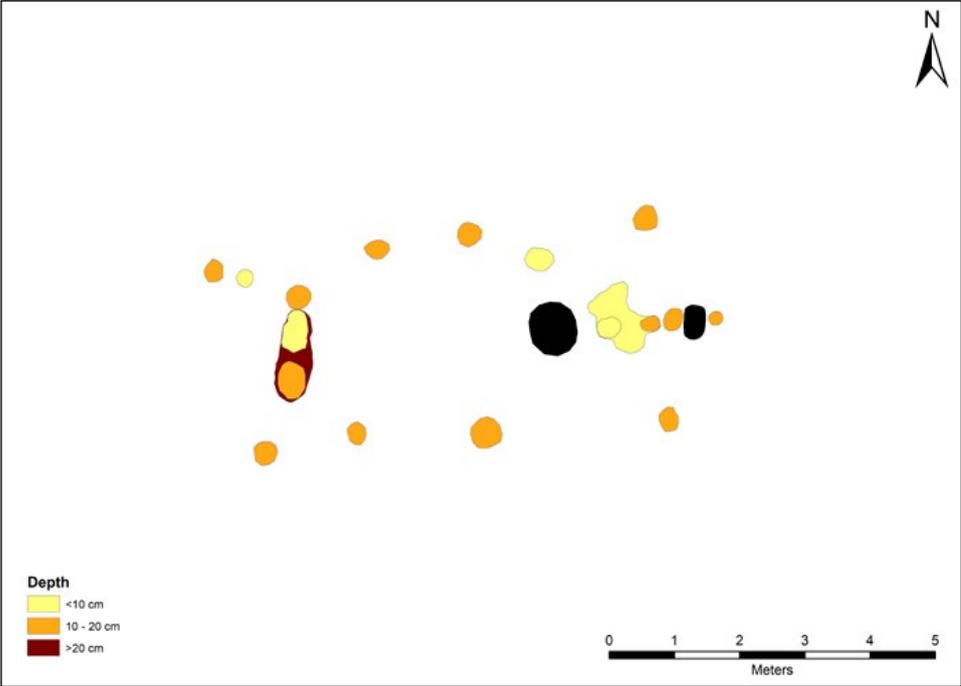
Figure 16. House 13, Field B. Illustration: Magnar Mojaren Gran, NTNU University Museum.

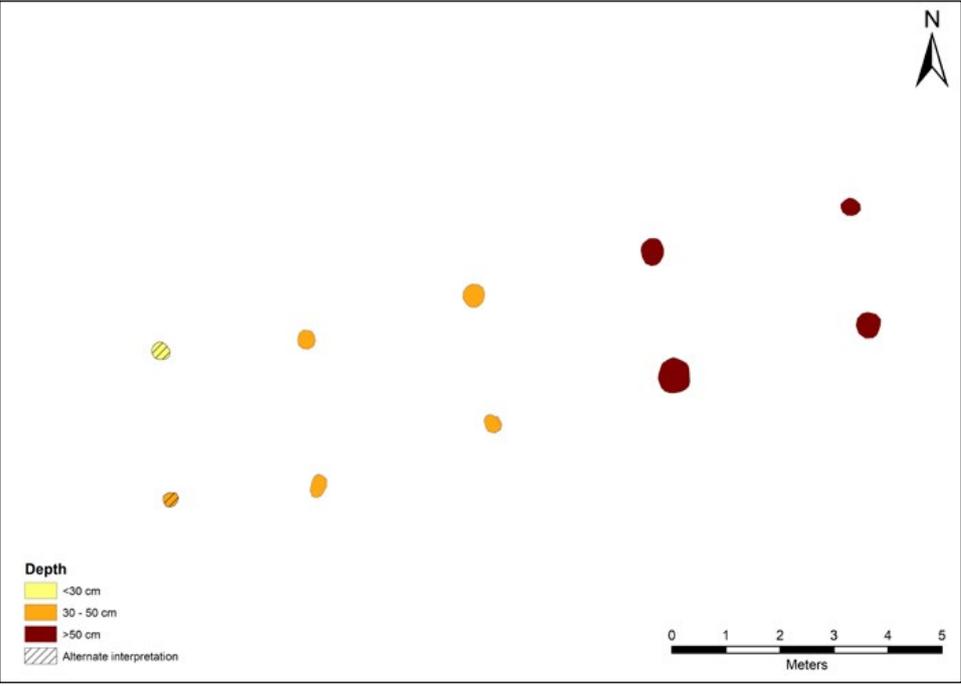
Figure 17. House 18, Field C. Illustration: Magnar Mojaren Gran, NTNU University Museum.
