## CHAPTER 6

# Roman Iron Age and Migration period building traditions and settlement organisation at Vik, Ørland

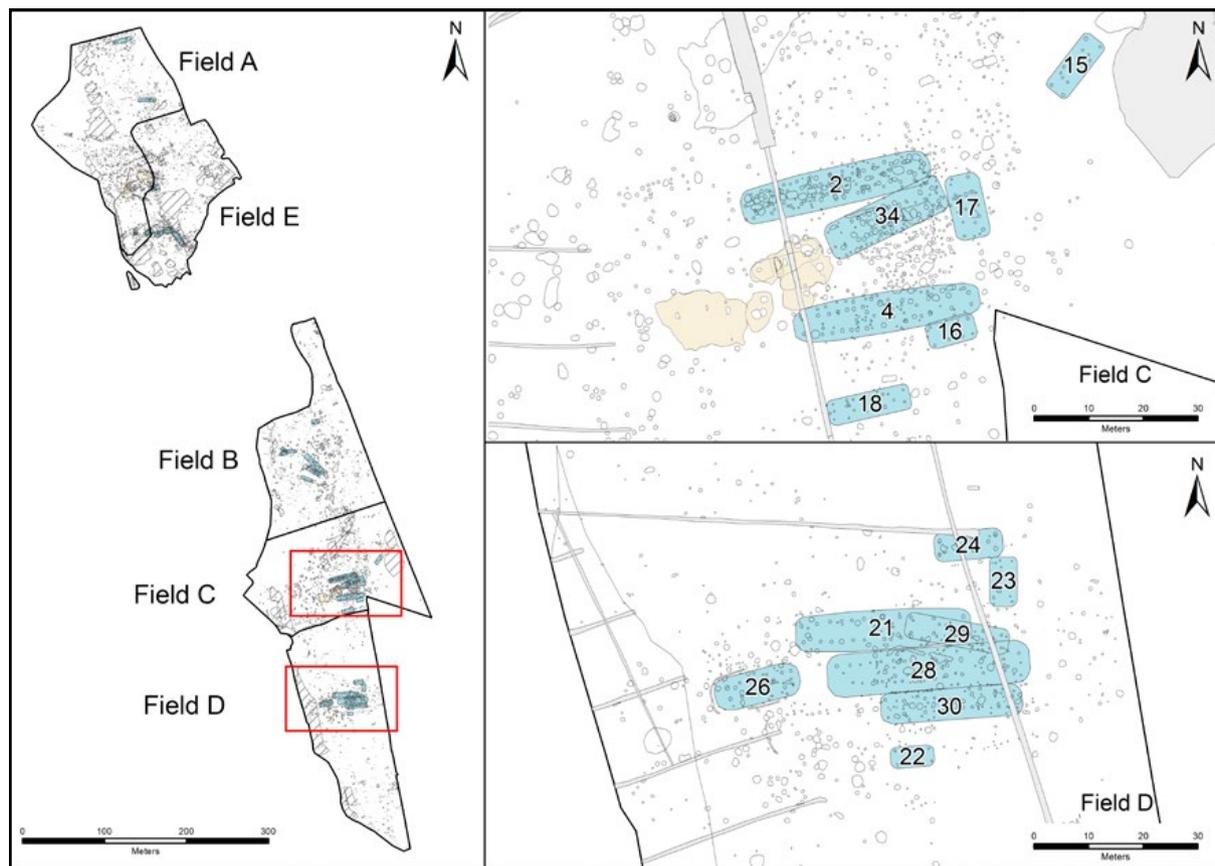
Figure 1. The Roman Iron Age and Migration Period settlement in Fields C and D, in the southern part of the excavation area at Vik. Illustration: Magnar Mojaren Gran, NTNU University Museum.

On Field C, two longhouses (Longhouse 4 and 34, see Figure 1) and two smaller buildings (16 and 17) can be dated to the Early Roman Iron Age.

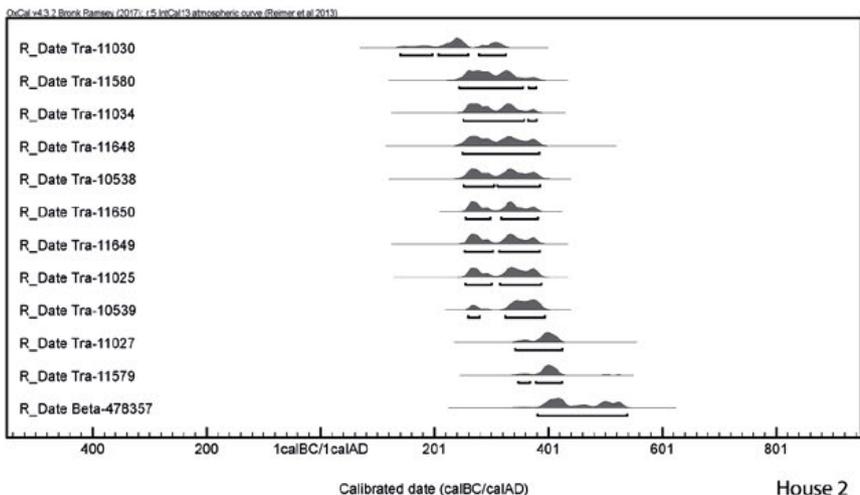
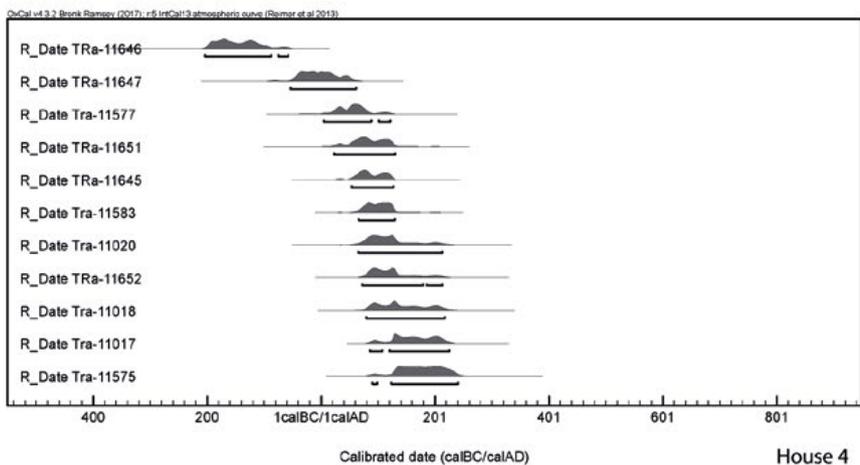
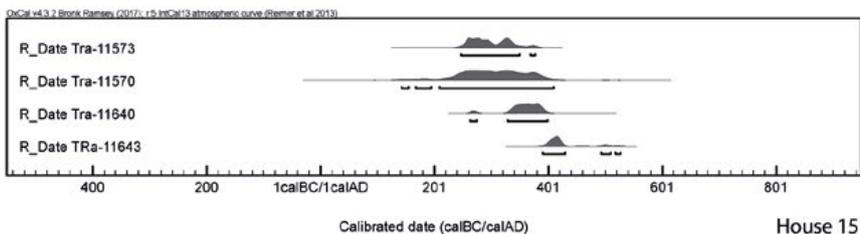
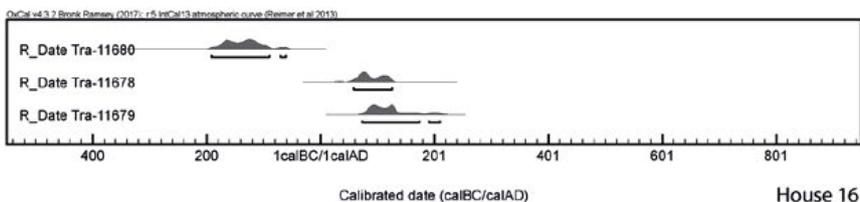
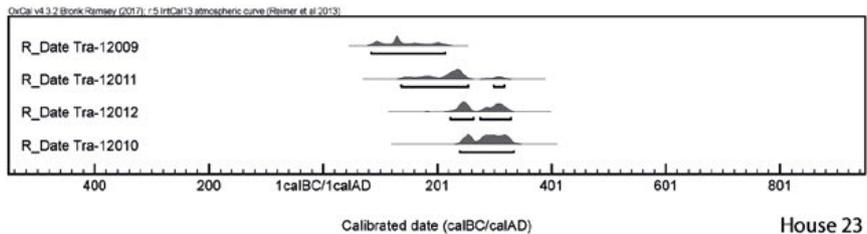
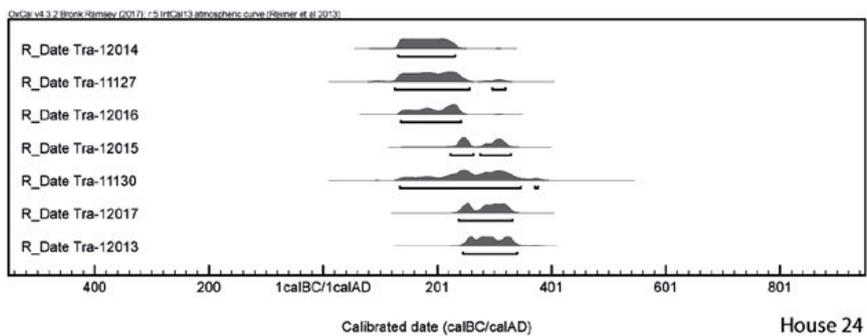
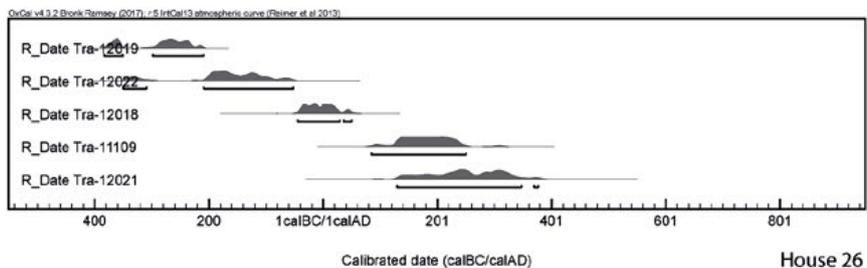
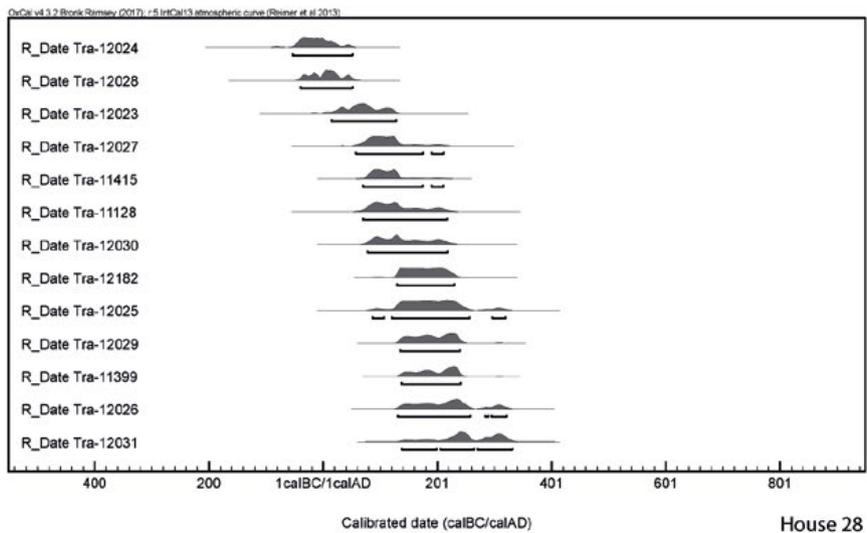
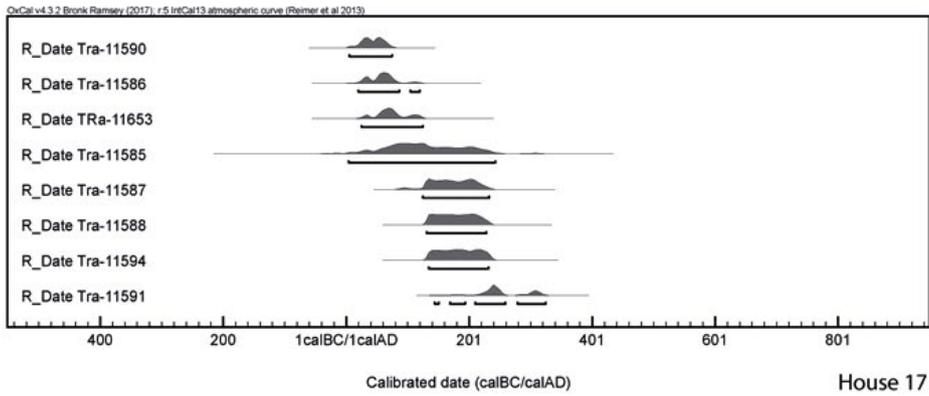
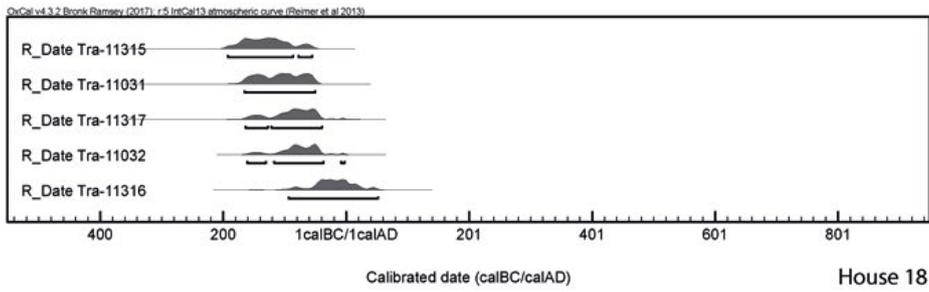
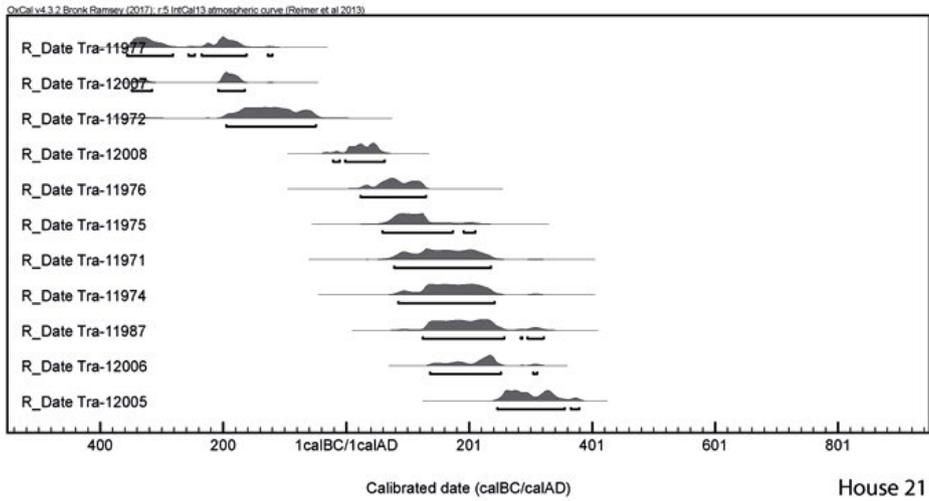
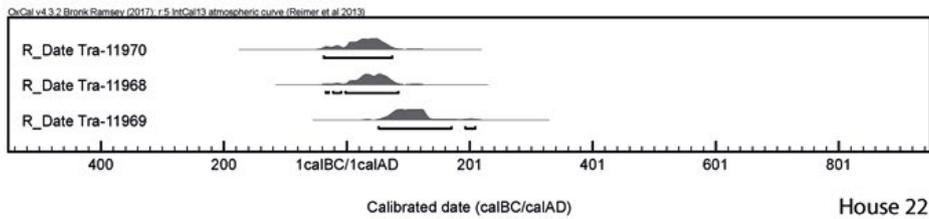
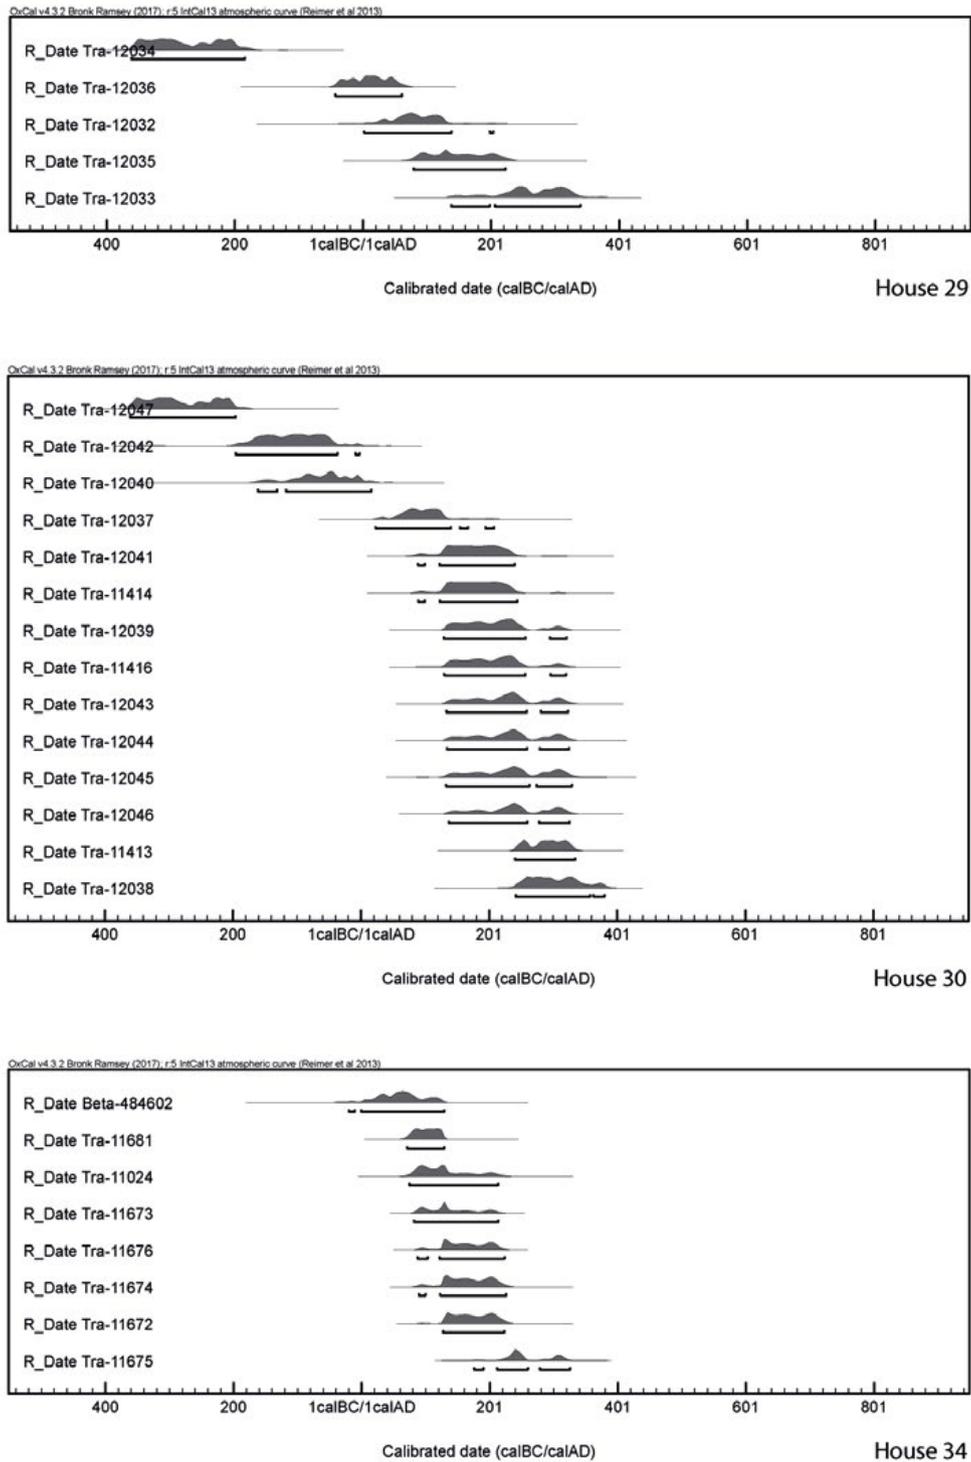
Figure 2. <sup>14</sup>C-dates from the buildings in Fields C and D, Southern Vik.

The majority of the dates of both longhouses fall approximately within the period 50–220 AD (see Figure 2). It is, however, not possible to establish a chronological relationship between longhouses 4 and 34, since the  $^{14}\text{C}$  dates are wide and largely overlapping. The latest phase is represented by Longhouse 2a/2b and a smaller building 15, all of which can be placed to the Late Roman Iron Age/Early Migration Period.

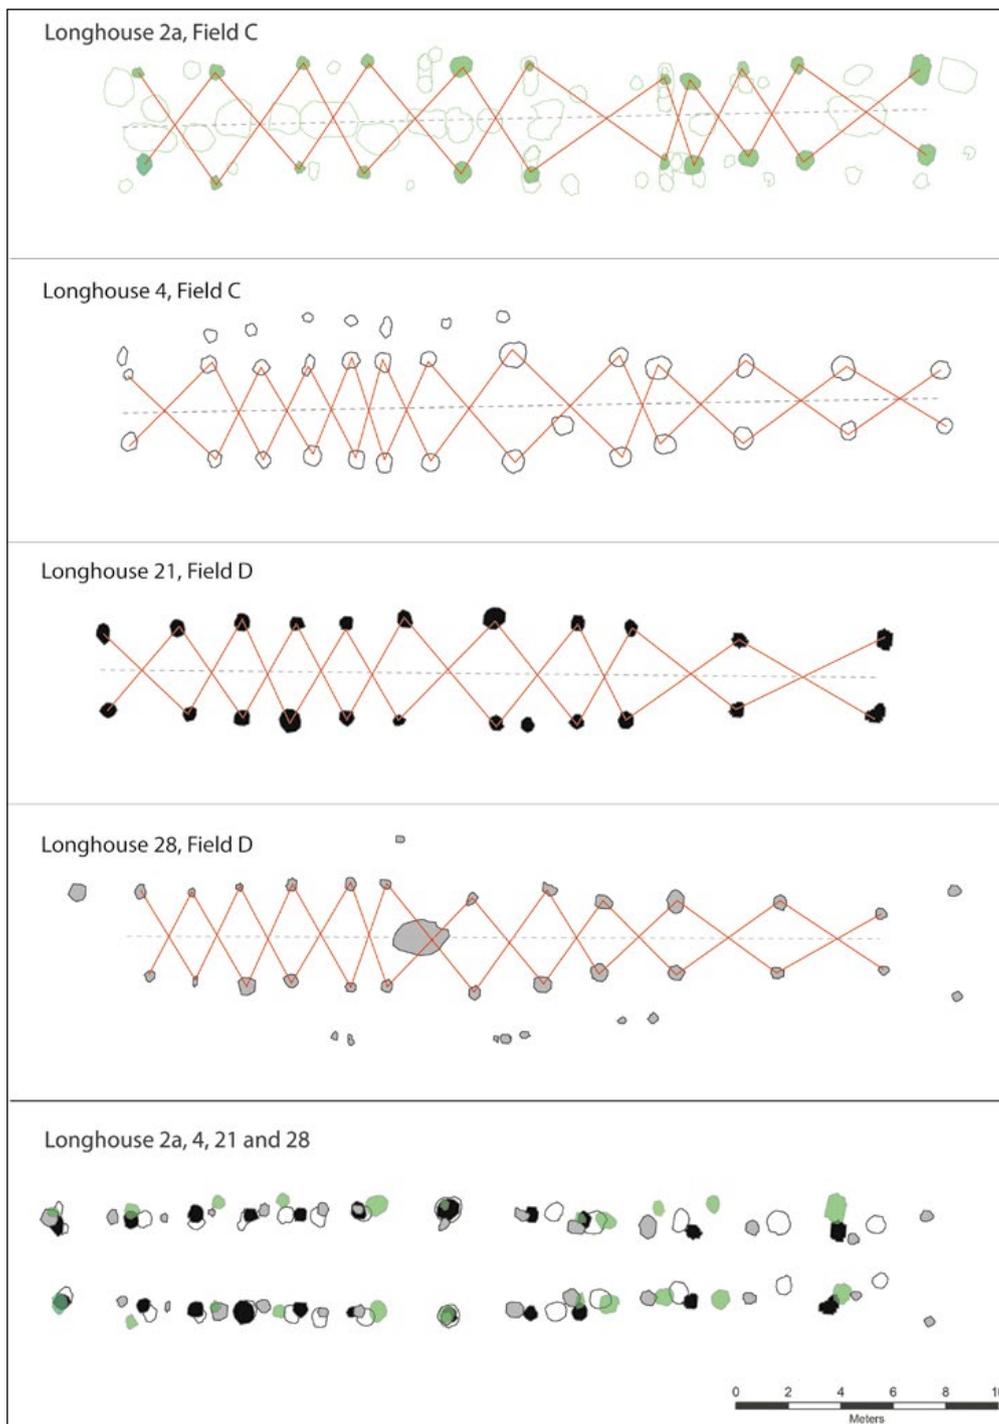
**Figure 3.** Longhouses 2a, 4, 21 and 28. Individually presented with geometric features displayed and as a compilation showing only roof-supporting posts. Illustration: Astrid B. Lorentzen, NTNU University Museum.

As shown in Figure 3, the roof-bearing posts in all four longhouses are consistent with the geometric principles described above. Although Longhouse 2a at first glance appeared very different from the rest, the layout of the roof-supporting posts is comparable

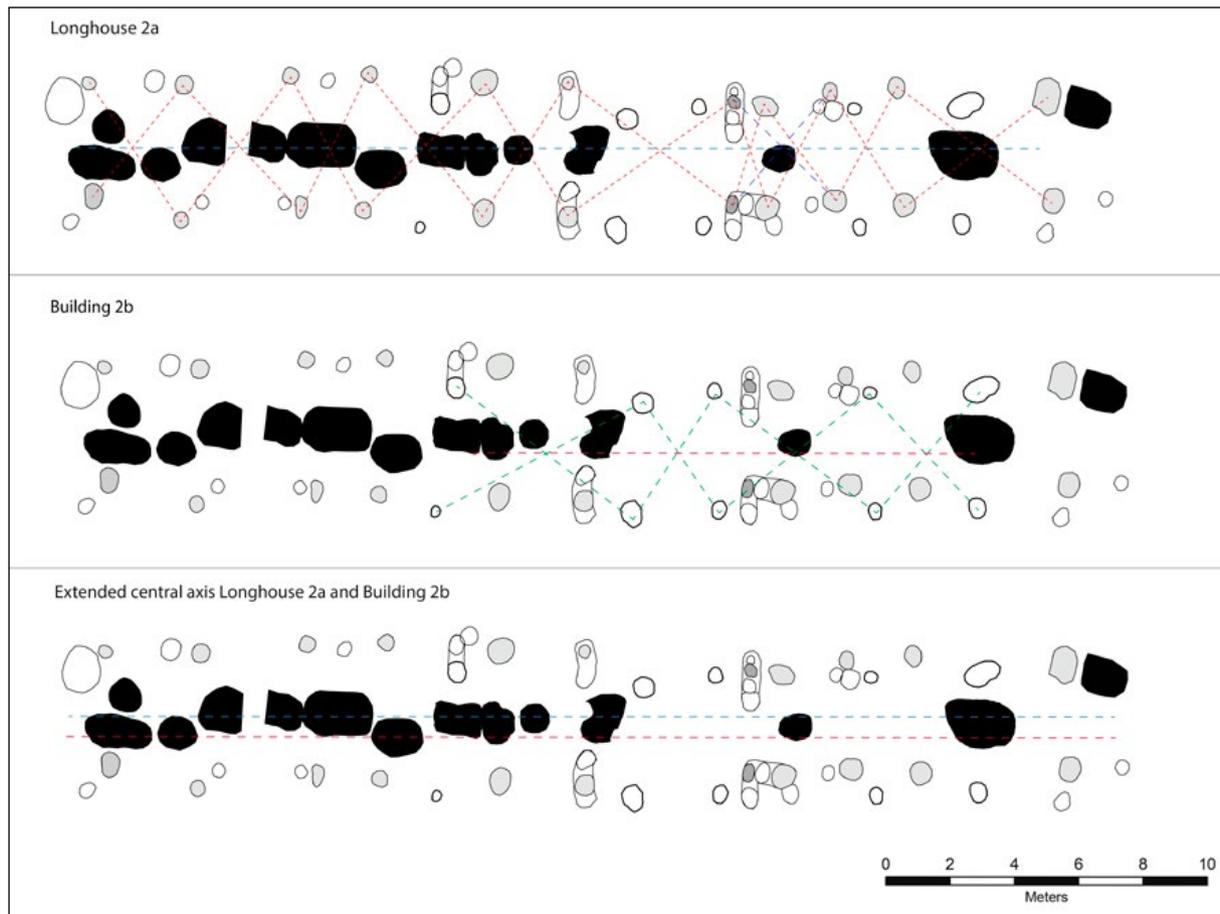
**Figure 4.** Longhouse 2a and Building 2b, individually presented with geometric features and as a compilation showing the relation between the buildings' central axis. Please note the two options for the symmetrical post-pairs in the eastern end of house 2, as indicated by the blue line (top illustration). Illustration: Astrid B. Lorentzen, NTNU University Museum.

to the earlier buildings 4, 21 and 28. The sections of Longhouse 2a may, however, have functioned differently compared with earlier periods (see fig. 4). The symmetric analysis also indicates that several posts in the eastern section form a separate, but parallel alignment to the main axis of Longhouse 2a. These postholes (termed 2b) could either be interpreted as a separate 17 m long building or, more likely, a repair/different phase of Longhouse 2a. The posts of 2b were certainly filled with the same dark,

distinctive material as those of Longhouse 2a, and the parallel alignment does not seem coincidental. Moreover, it may be noted that if the axial line were to be extended west of 2b, three fireplaces would sit neatly on the centre of the axial line. This *could* indicate that the phase 2b building was originally longer, but that the remains in this part had not survived. In the rest of this article, House 2a and 2b are therefore regarded as two phases of continued occupation.

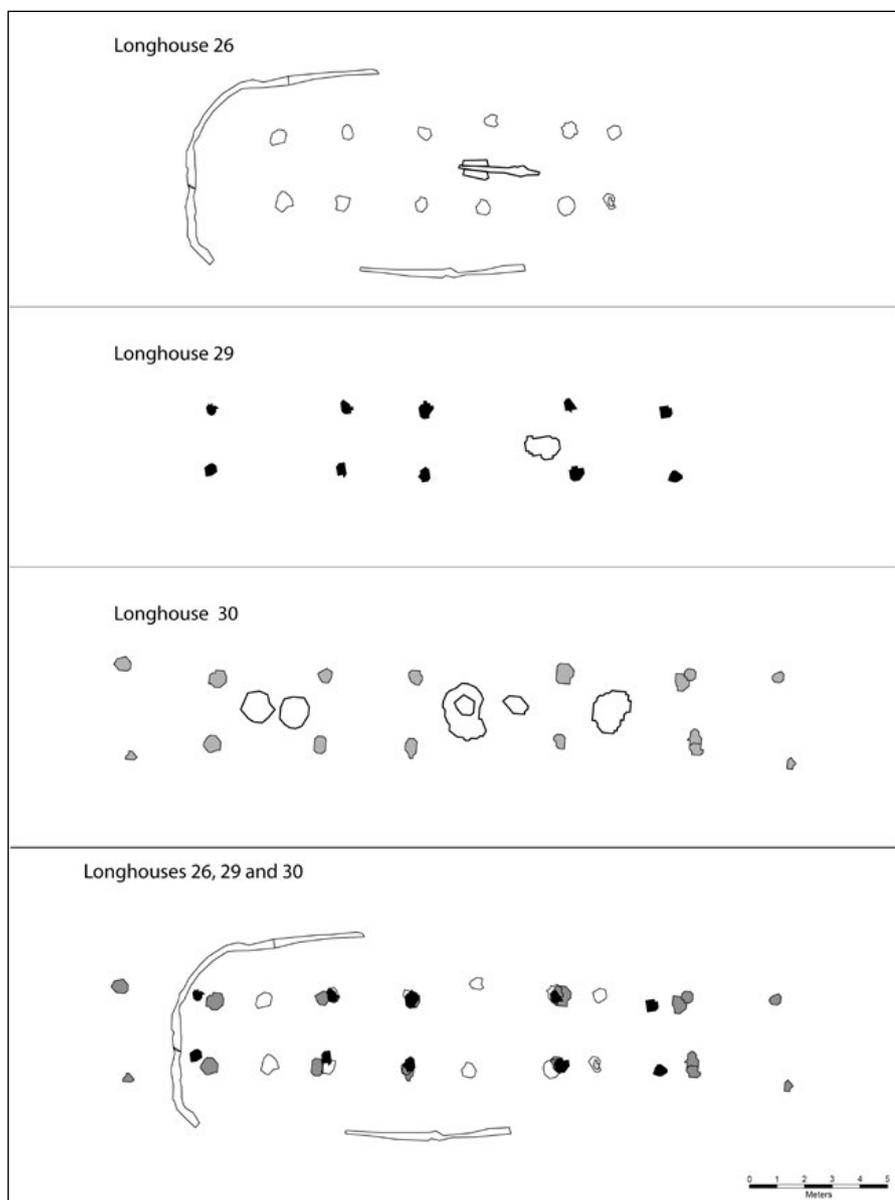
**Figure 5.** Longhouses 26, 29 and 30 presented individually and as a compilation. Illustration: Astrid B. Lorentzen, NTNU University Museum.

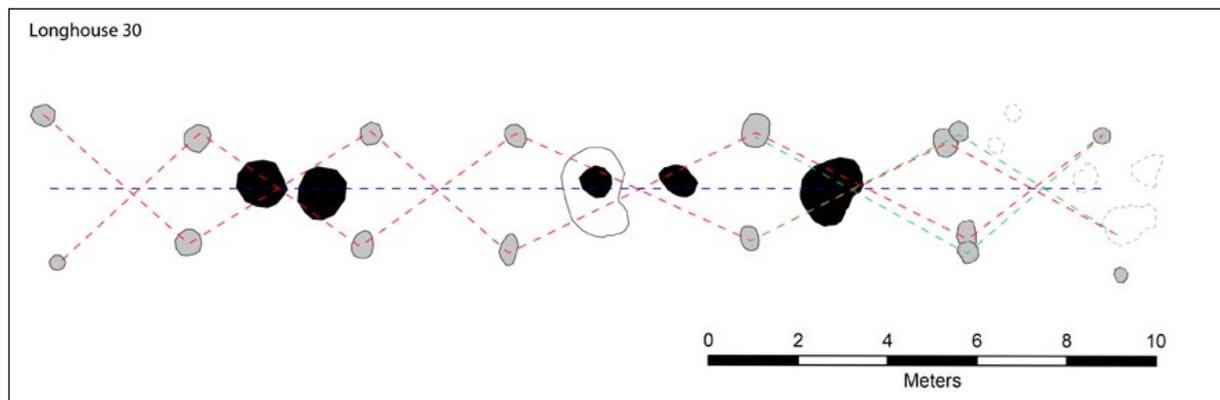
Figure 6. Longhouse 30, with evidence of rebuild, and asymmetrical corner posts. Illustration: Astrid B. Lorentzen, NTNU University Museum.

two pairs of corner posts, one of which seems to be a repair/replacement (Figure 6). As shown in Figure 6, both phases are true to the geometrical layout of the longhouse and a later context might have disturbed the original eastern corner post.

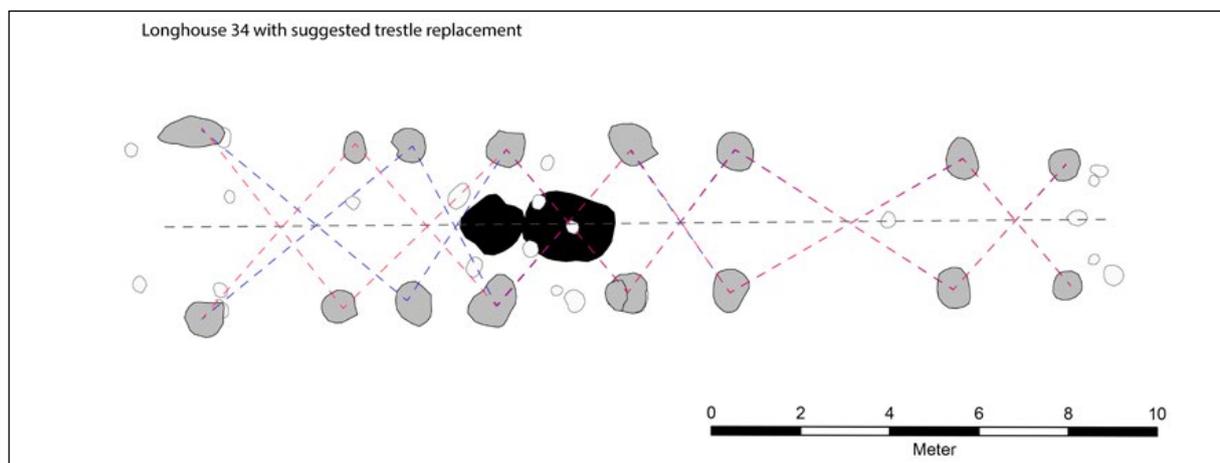
Figure 7. Longhouse 34 with evidence of trestle replacement maintaining the symmetry in the longhouses central axis, in comparison to an unsymmetrical axis in the case of all trestles being concurrent. Illustration: Astrid B. Lorentzen, NTNU University Museum.

The geometric examination of house 34 identified evidence of repair in the western section: a trestle replacement that maintained the building's symmetric mid-axis. Figure 7 shows what we interpret as the original placement of the trestle foundations, regularly placed at an equal distance (red dotted line).

At a later stage, the area east of the fireplaces has undergone a repair, as is evident by the addition of two extra trestles (blue dotted line). This represents a deviation from longhouses 2, 4, 21 and 28 since there is not a symmetric arrangement between the second and third trestle, but each of these has symmetry with the first and fourth trestle. This indicates that the two trestles did not stand at the same time, but that one of them (possibly the third trestle) has replaced the other (possibly the second trestle) while the building was still standing.

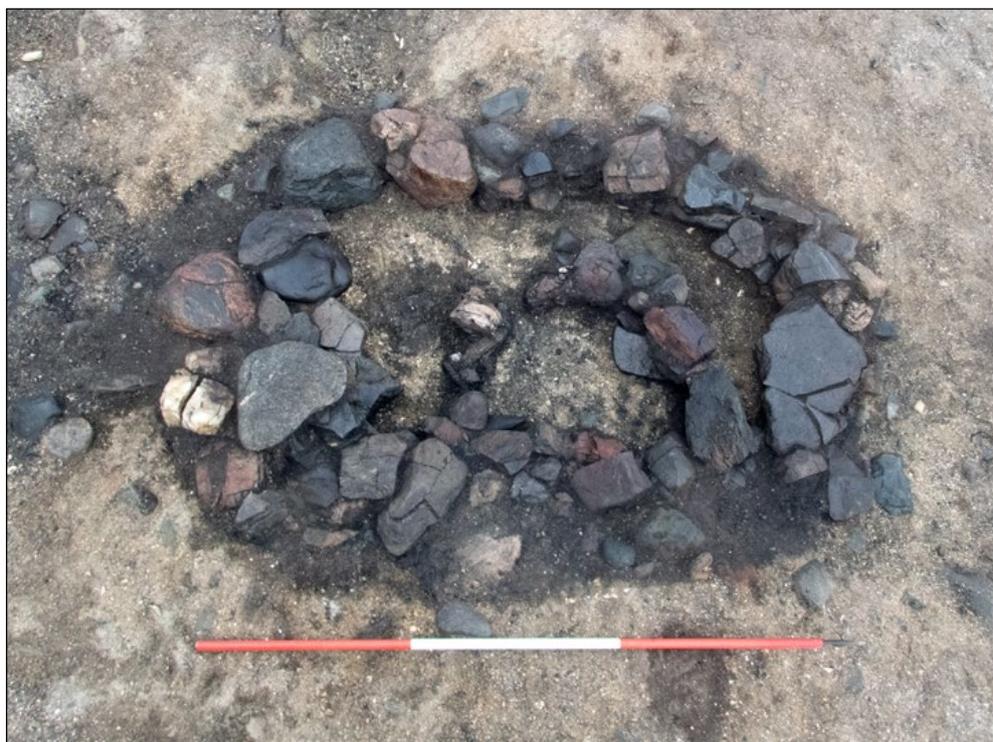
**Figure 8.** A well-preserved fire-place in Longhouse 2a. Photo: NTNU University Museum.

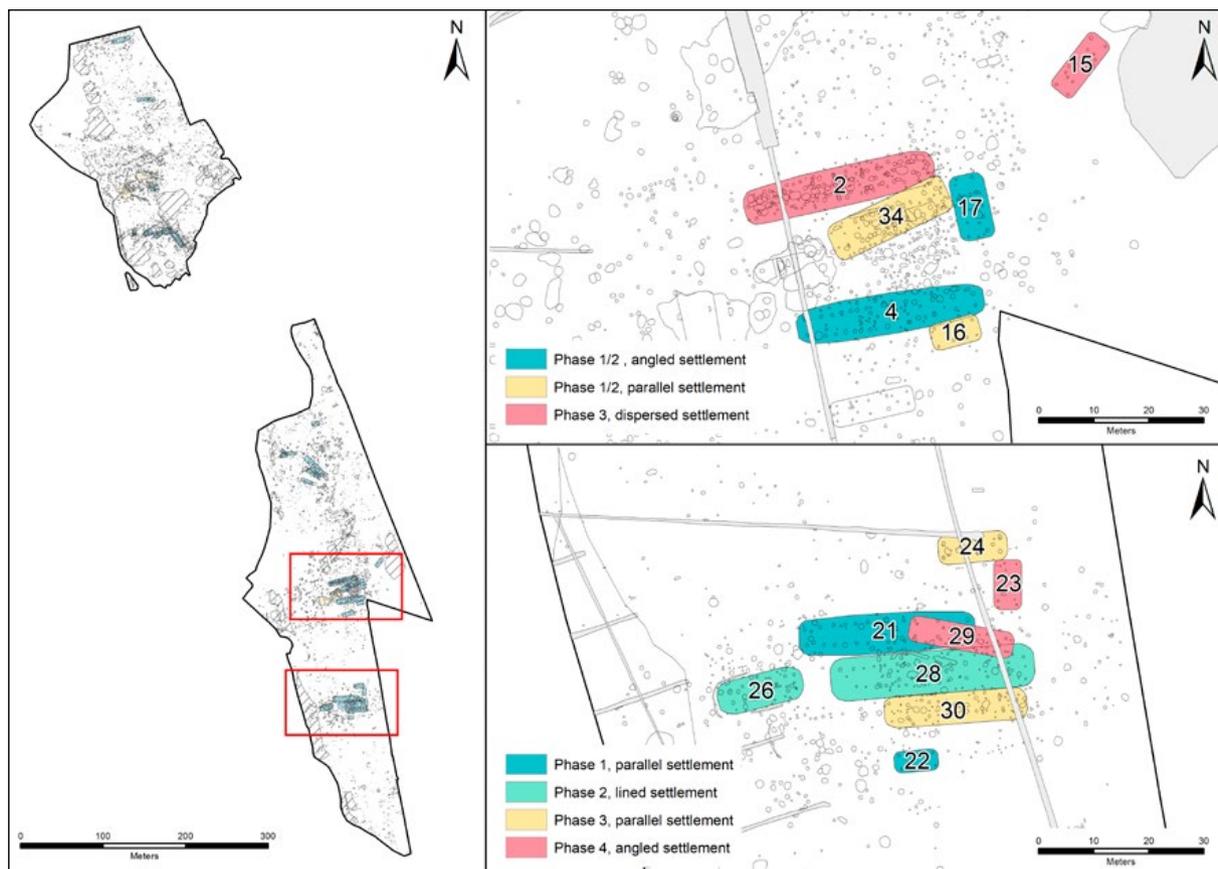
**Figure 9.** The different phases of settlement in the southern area of Vik in the Roman Iron Age and Migration Period. Illustration: Magnar Mojaren Gran, NTNU University Museum.
