CHAPTER 13

The northern Scandinavian Viking hall: A case study from Viklem in Ørland, Norway

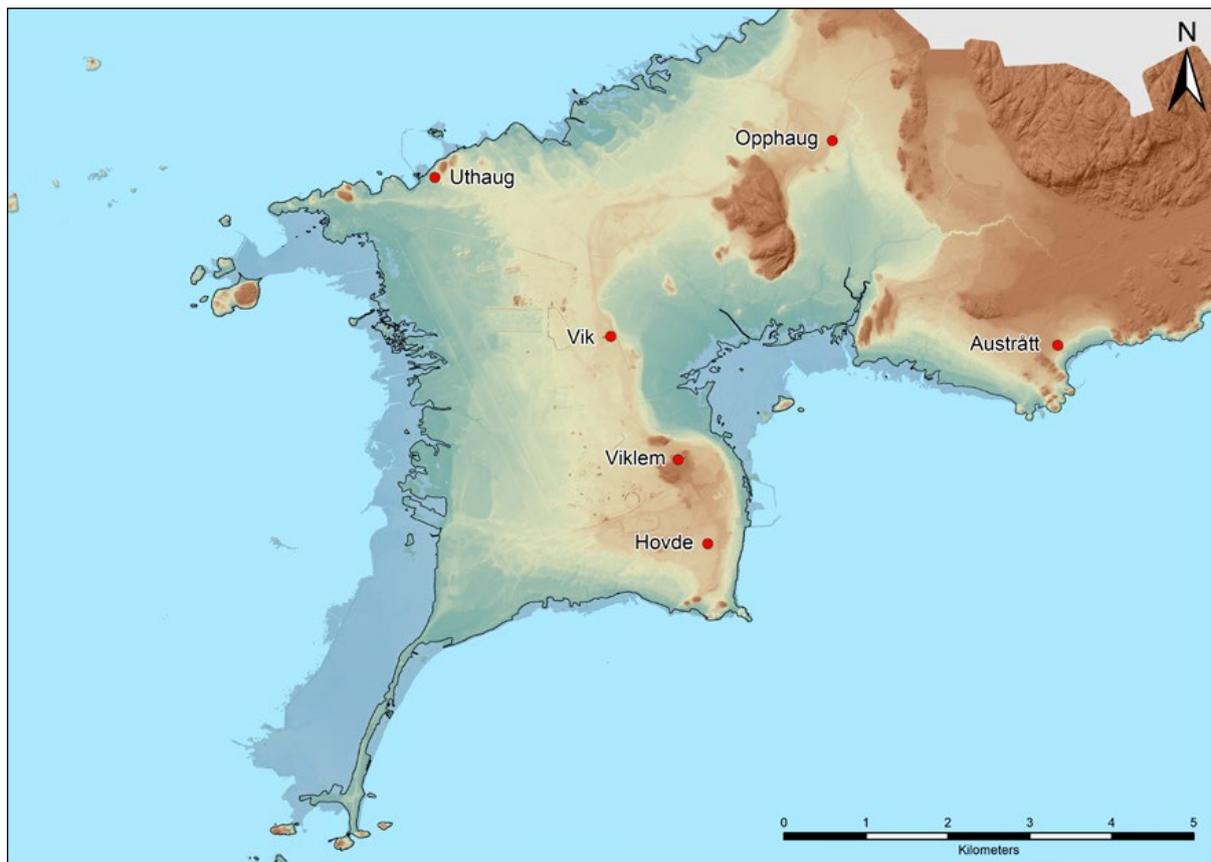
Figure 2. Ørland with the position of the shoreline at 3 m asl. Map by Magnar Mojaren Gran, NTNU University Museum.

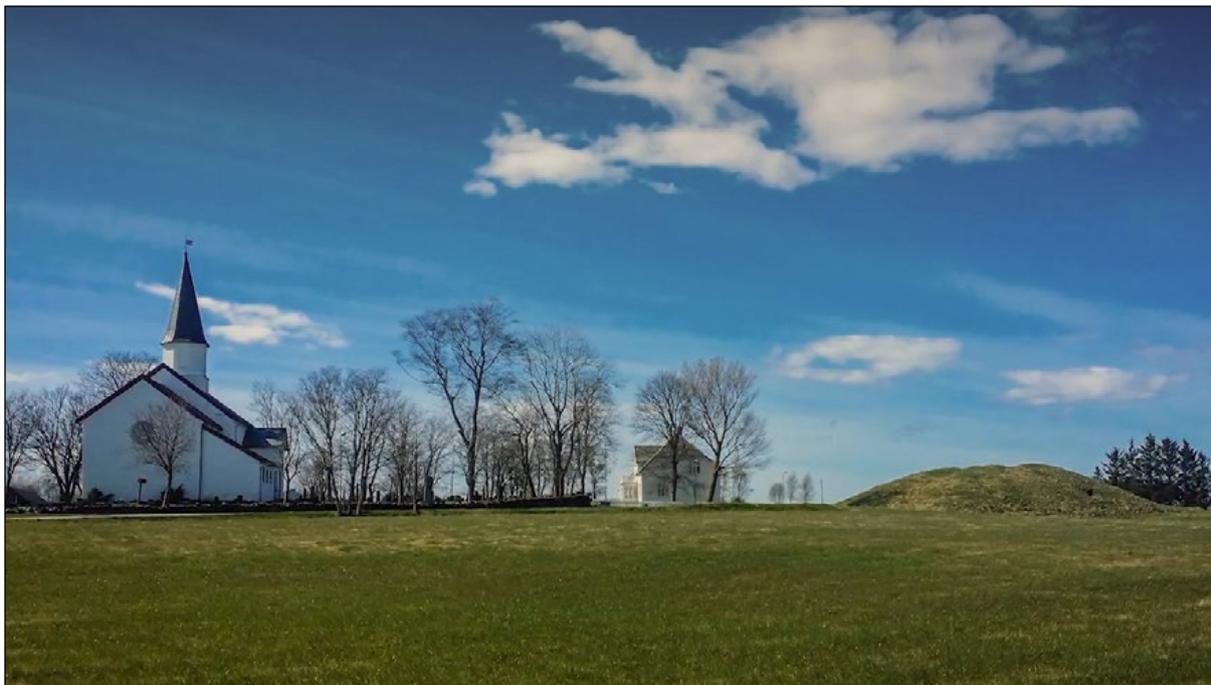
Figure 3. The church and the large burial mound at Viklem. Photo: Kristian Pettersen.

(Figure 3), it can be seen that they were on the periphery of the occupied area, just on the edge of the plateau to the north. Traces have been found of several possible buildings associated with the Viking and medieval farmstead to the west and east, and thick layers of cultural deposits from the medieval farm are known to exist within the courtyard of the modern farmstead just to the southeast. The halls clearly lie within the northern boundary of

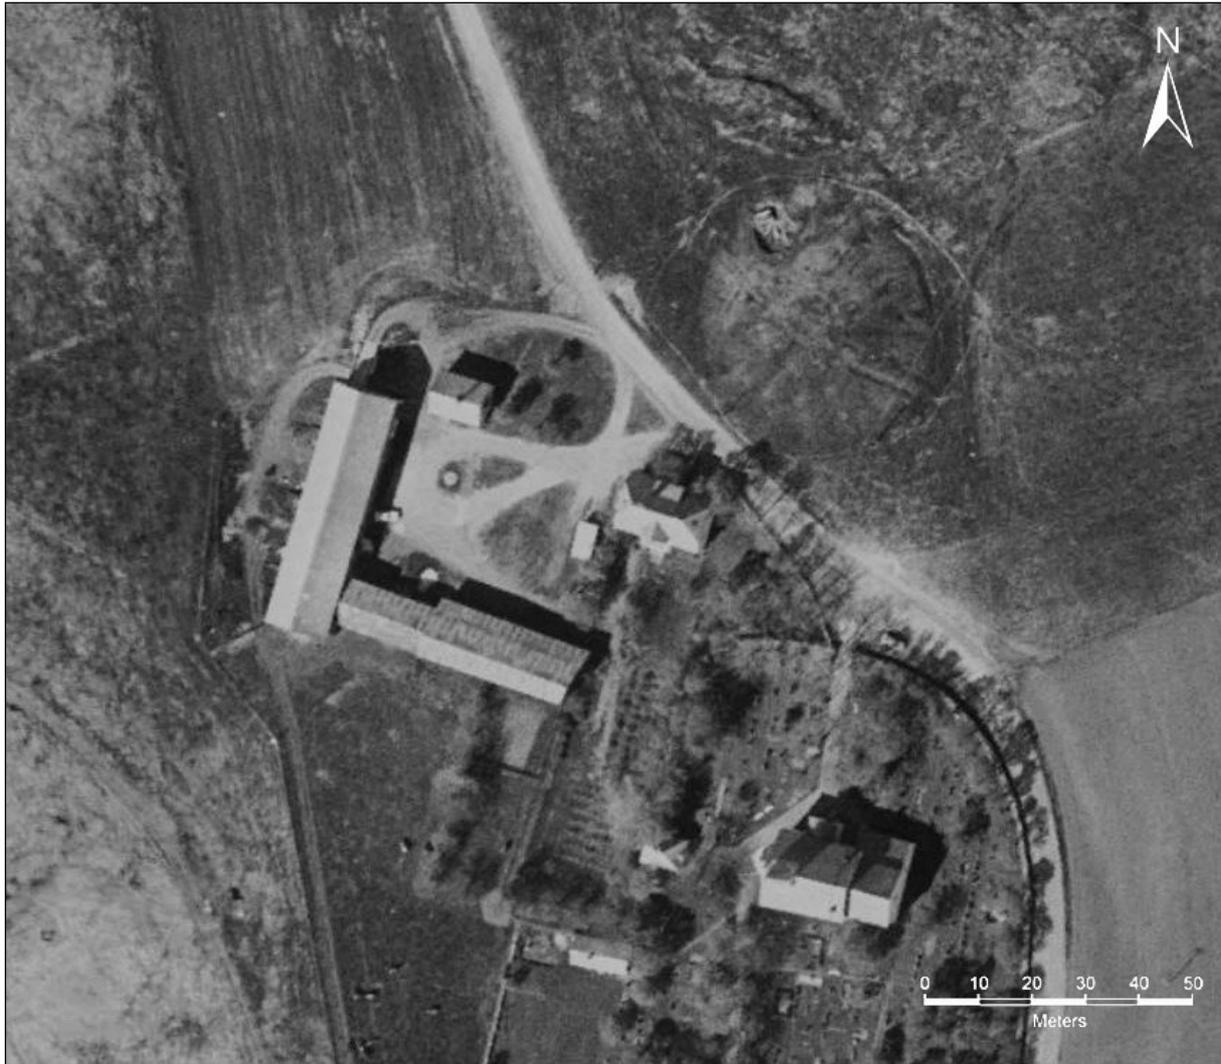
Figure 4. Aerial photo from 1969 showing Viklem farm, church, churchyard and the burial mound (Norgesbilder.no).

photographs show traces of a *potetkjeller* (a partly stone-built construction for storing potatoes and other root vegetables) in the northwest, as well as traces of trenches dug across the mound (Figure 4). We do not have any information about who dug the trenches or whether there were any finds from them. However, in 2002, a square exploratory trench measuring 1 m² was dug at the base of the mound (Berglund & Solem 2017:224). A possible burnt layer was found at the base of the mound, above which a row of three stones was visible, and interpreted as possibly forming part of a stone circle. Charcoal from the bottom layer was dated to the Bronze Age and pre-Roman Iron Age (BC 800–555 (Tua-4202, 2550 +/- 50 BP) (Berglund & Solem 2017:224). The excavation only afforded a brief insight into the edge of the burial mound. Notably, no clear connection was established between the burnt layer and the burial mound. The latter point has also been emphasized by Berglund & Solem (2017:224), who think that

Besides the Viklem burial mound, the white-washed church is the only early monument visible in Viklem today (Figure 4). The church has a complex construction history. The building that exists

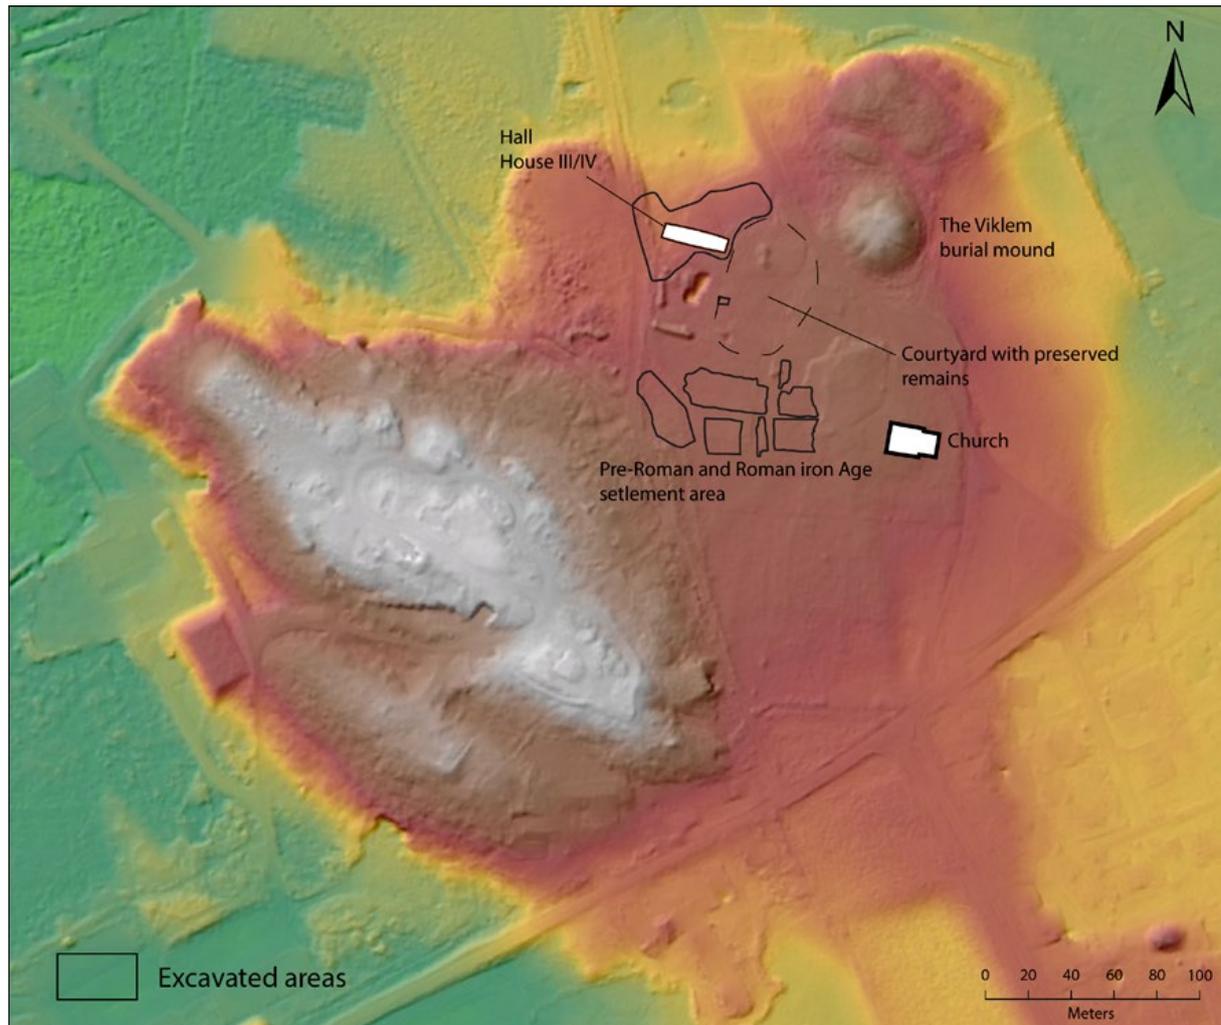
Figure 5. The Viklem plateau with the main monuments and archaeological observations. Map by Raymond Sauvage, 3D data by Hoydedata.no/Kartverket.

Viklem forms a plateau with some rocky formations (Figure 5), that lies elevated in the flat landscape of western Ørland. The area is clearly visible from the surrounding countryside and, conversely, it has commanding views of the surrounding landscape, as well as of the route ships took when entering the fjord. As mentioned elsewhere in this volume, the shoreline changes in the flat Ørland landscape had a major impact on the location of settlements and led to changing harbour conditions (Ystgaard, Gran & Fransson, Ch. 1). In the Early Iron Age there was an archipelago between Viklem, Vik, and Opphaug, in the location where there is dry land today. During the Iron Age, the rising land led

the farm (Figure 5). We suspect there was a harbour c.500–600 m to the north of Viklem (Figure 6), and, if that were the case, the halls would have been highly visible due to their orientation. Thus, for those travelling from the harbour and up to the Viklem plateau, the halls and not least the nearby burial mound must have been clearly in view as prominent monuments in the landscape.

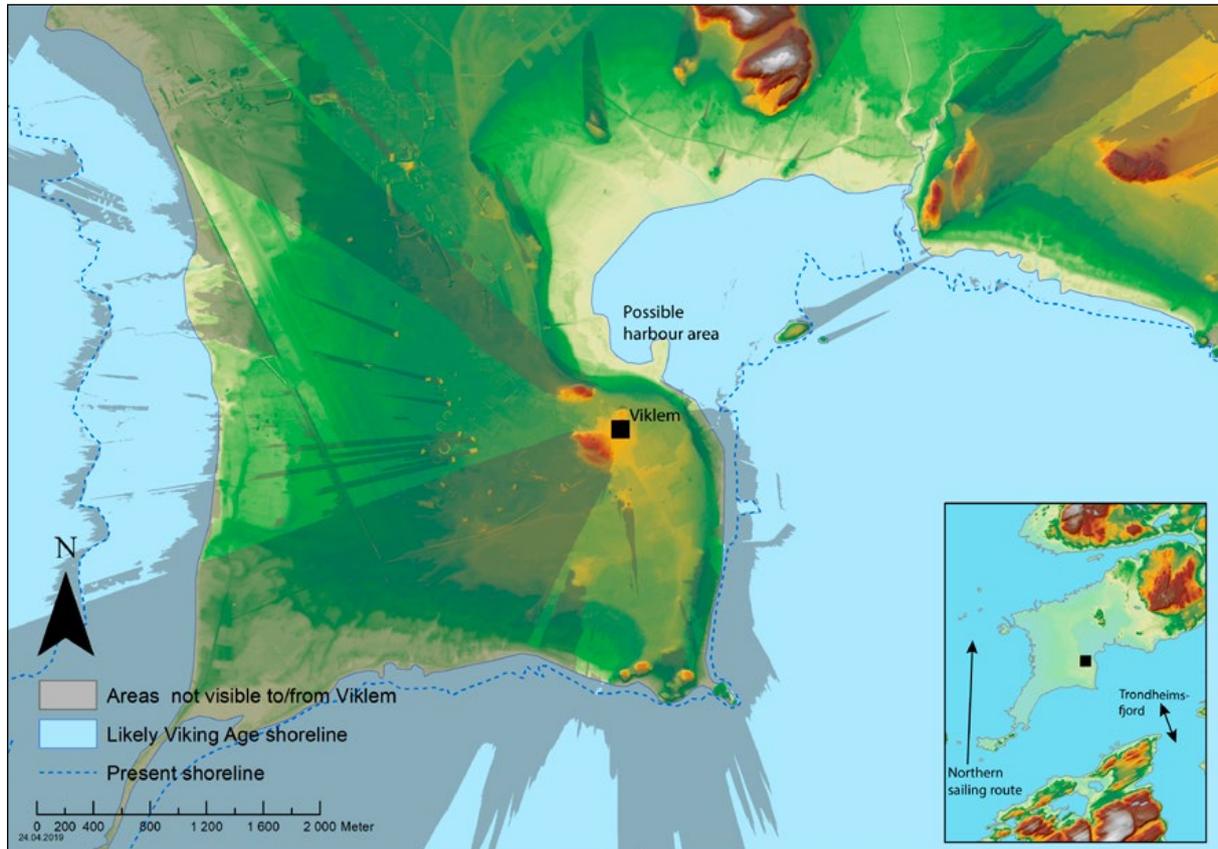
Figure 6. Viewshed analysis of Viklem. The monuments could be seen from the green areas in the map. The possible harbour area lies to the north. GIS application by Raymond Sauvage, NTNU University Museum, 3D data by Hoydedata.no/Kartverket.

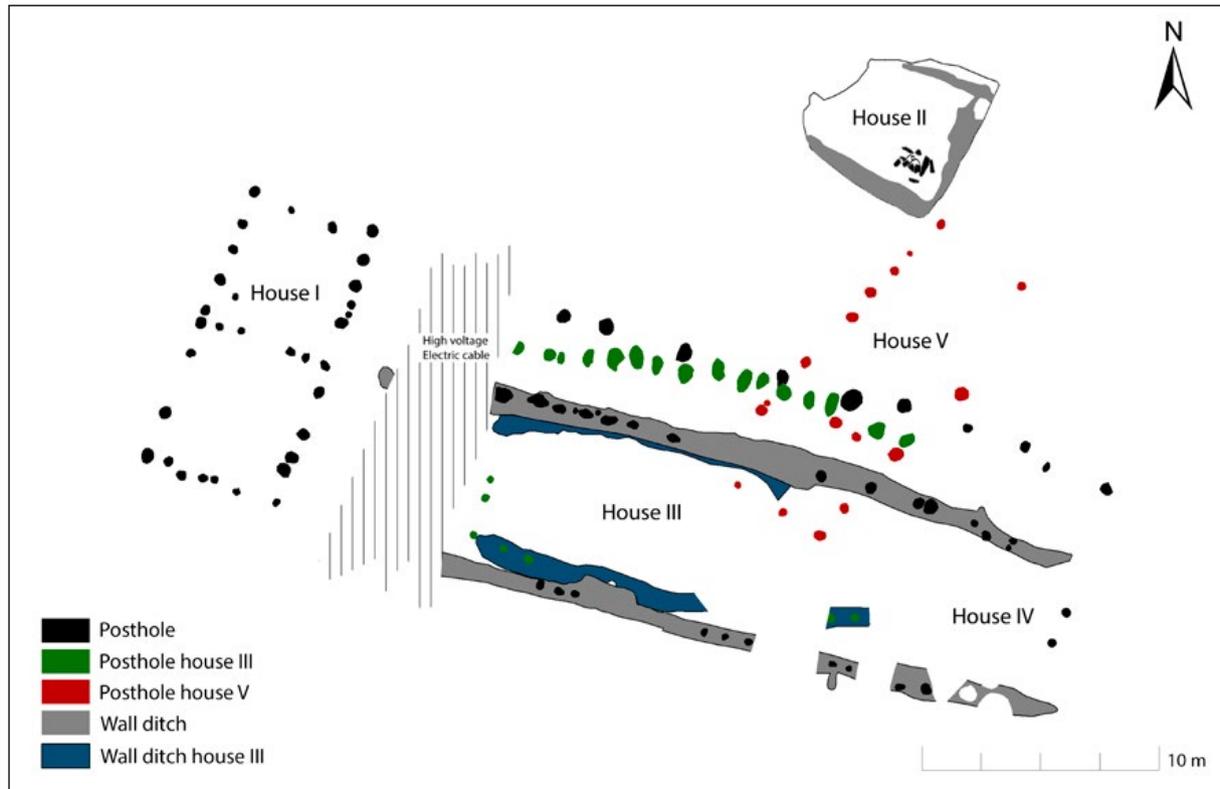
Figure 7. Plan of buildings excavated in 2014. Illustration by Raymond Sauvage, NTNU University Museum.

Description of all buildings and finds from 2014 have been published (Sauvage & Mokkelbost 2016), and are only treated superficially here; an overview of them is presented in Figure 7. A rectangular single-aisled house measuring 12.5 m × 6 m (House 1) dated to approximately AD 975–1030, and a large pit house measuring c.6.5 m × 6.5 m (House 2) with a large, stone-lined hearth in one corner, dated to AD 970–1164. Several finds from the pit house will be discussed later (in the section headed '*Artefacts from the 2014 investigations*'). In addition, a rectangular single-aisled house was discovered (House 5). Stratigraphically, it was later than Houses 3 and 4 and differed from them in orientation, and has therefore been interpreted as a later element.

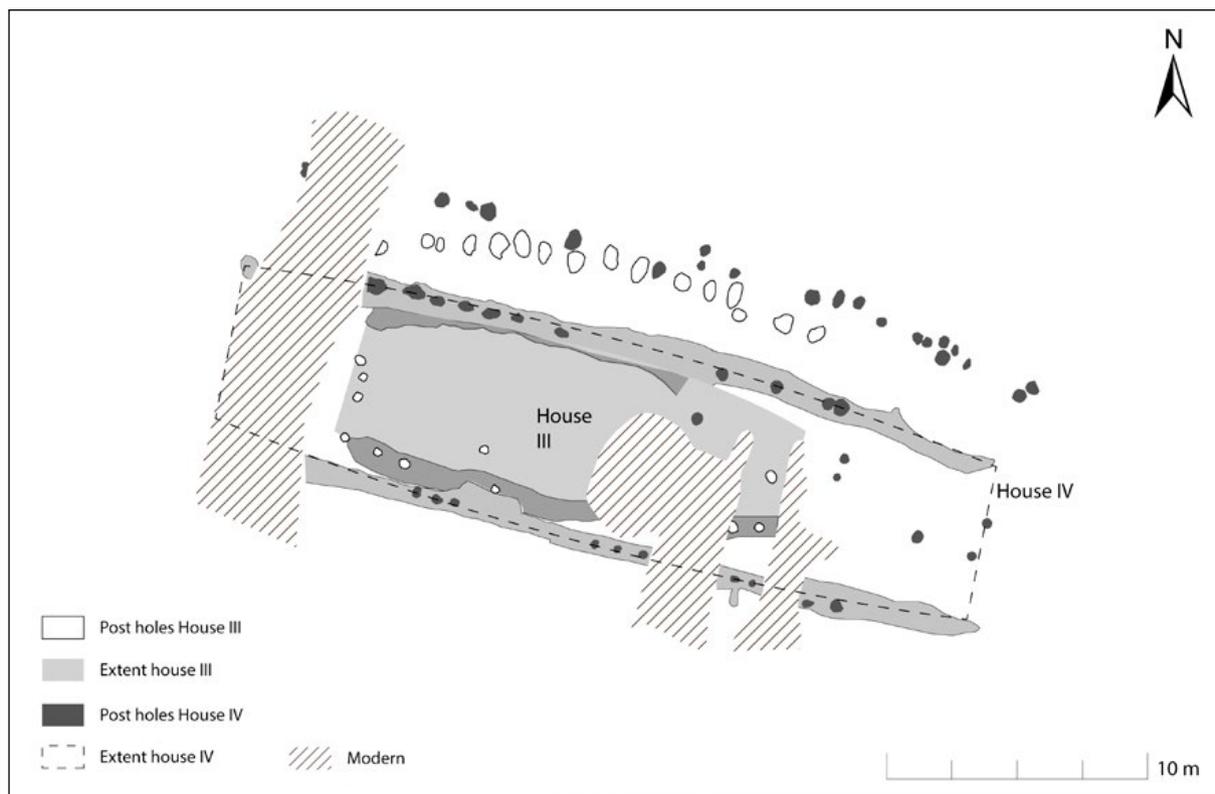
Figure 8. Plan of the hall buildings, Houses 3 and 4. Illustration by Raymond Sauvage, NTNU University Museum.

The two buildings that we focus mainly on in this article are the single-aisled Houses 3 and 4, which we think may be examples of central Scandinavian halls (Figure 8).

Houses 3 and 4 have been described in detail by Sauvage & Mokkelbost (2016:280–283) and in the excavation report for the 2014 investigations (Mokkelbost & Sauvage 2015). These houses differ significantly from the buildings excavated at Viklem, especially in terms of their size, the fact that they had the same orientation and were similar in design and construction method, and the fact that one overlapped the other. The earliest house, House 3, was 18 m in length and 7 m wide, and its long walls were convex in plan. In the long walls, roof-supporting wall posts were set in wall trenches up to 50 cm deep. Although the trenches had been disturbed by later activity, it was still possible to observe postholes at intervals of c.80 cm. Outside the northeastern wall trench there was a slightly curved row of 16

posts set in oblique-angled postholes, which have been interpreted as supporting posts (*skårder*) for the northern long wall. Postholes at the gable ends marked the position of the end walls. There were no clear traces of internal divisions, and thus all remains indicated that the building had only one room, with an area of 140 m². Radiocarbon dating of charcoal from an internal posthole (Table 1) securely linked the posthole to the house, but since there were no traces of other internal posts, it is not interpreted as part of an internal partition. Because of this the post must have been erected in connection with other activities. The strong roof-supporting wall elements and the external angled supporting posts suggest that the house had a strong foundation and therefore was probably a tall building. Remains of

House 4 was built immediately after House 3 had been burnt. The new house was at least 27 m in length and 8.8 m in width. To the north, the excavated area of the house was disturbed by a modern cable trench, and therefore the total length of the house is somewhat uncertain. However, the possible end of the northern wall trench was observed just west of the modern trench and may indicate that the house was originally 30 m in length. In common with its predecessor, House 4 had strong foundation posts set in two parallel wall trenches. However, unlike the long convex walls in the previous phase, the long walls were quite straight. The

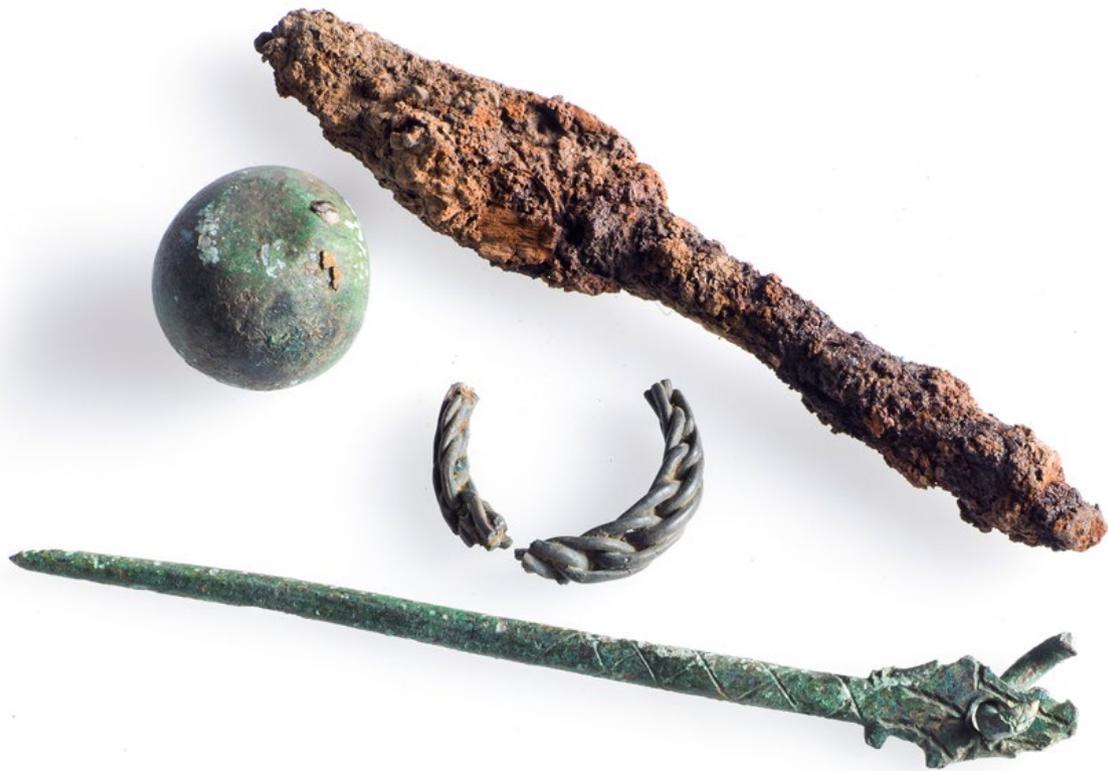
Figure 9. Metal objects from the pit house. Photo: Åge Hojem, NTNU University Museum.

Another group of discoveries was made higher up in the infill in the pit house. These included a bronze alloy ringed pin (Mokkelbost & Sauvage 2015:85). The pin is 8.2 cm long, with a flat head with linear decoration on both surfaces (Figure 9). The head is 1.6 cm long, has an uneven diamond

shape, and appears to have lost a number of protrusions. The upper 2.5 cm of the shaft below the head has linear decoration in the form of crossing lines. The ring was originally c.1 cm in diameter and was undecorated. The ringed pin probably belongs to a type called flat-headed ringed pins and might have been 'link-ringed' (Fanning 1994:109–110, Fig. 92). There do not seem to be any parallels in Norway; the nearest parallels have been found in Hedeby, Dublin, and Schleswig (Glørstad 2015:85). Another discovery from the same phase at Viklem is a finger ring 2–3 cm in diameter and made of braided silver threads (Figure 9). The ring was initially thought to have been made of bronze (Mokkelbost & Sauvage 2015:95), and the fact that it was silver was only revealed during conservation (conservator Leena Airola, pers.comm. March 2015). The ring is similar in appearance to a Viking gold ring from Waterford in Ireland (Bøe 1940:105, Fig. 72).

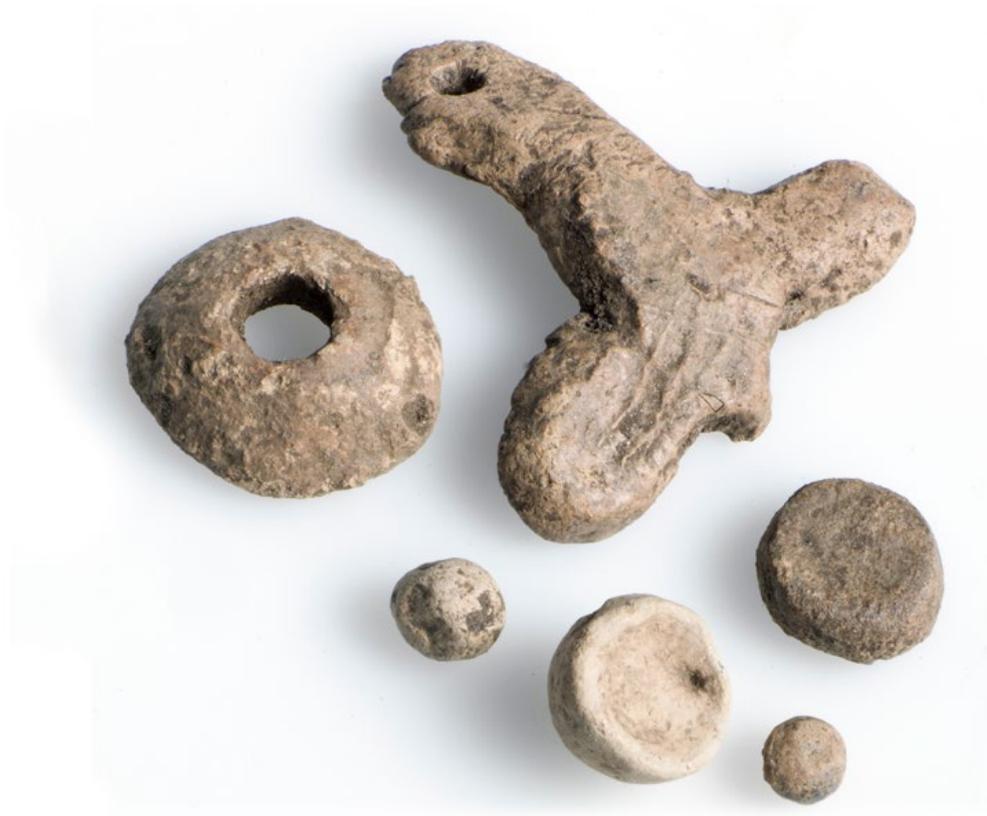
Figure 10. Finds made by metal detection, with the possible Thor's hammer. Photo: Åge Hojem, NTNU University Museum.

A third group of finds comprises surface finds from the ploughsoil, found by metal detection in advance of the archaeological investigations in 2014 (Figure 10). They consist of four possible weights, and one or two possible lead seals. Other surface finds include a pendant (the shape of which is reminiscent of Thor's hammer), a conical lead spindle whorl, a copper alloy fitting, and some unidentified copper alloy fragments (Mokkelbost & Sauvage 2015:89–92). The four possible weights and lead seals are difficult to date typologically, as they do not have any distinguishing characteristics. A parallel for the spindle whorl was found in the pit house, and may date from the Viking Age or early Middle Ages. All of the finds came from north of the occupied area, where the terrain starts to slope down away from the site. Exploratory archaeological surveys there have only revealed two possible postholes (Mokkelbost & Sauvage 2015). Although the findings cannot be more closely related to contexts, buildings, and periods, they nevertheless reflect activities on the

Another exciting find is the possible Thor's hammer made of lead (T26288: 121), which was found by metal detection in the vicinity of the halls. The pendant was found in the ploughsoil and should therefore be considered an isolated find. However, its wider context means it is worth closer examination. According to Norse mythology, Thor's hammer Mjølne was made by dwarfs, and always hit any target. A Thor's hammer was the best protection that Åsgård (the home of the gods) could have had against the jotuns (giants), who were Thor's arch enemy (Steinsland 2005:203). The 'Thor's hammer' from Viklem is not a prestigious object and appears to have been home-made, but its symbolism was still the same – it would have afforded protection against evil forces. This symbolic item was in common use among the elite up to and including early Christian times (Steinsland 2005:203). The Norse sagas mention a Thor cult in Trøndelag, and, according to monk Oddr Snorrason's saga of Olav Tryggvason, Thor was worshiped at
